Laser & Injection system (ISYS) status

Virgo week November 2017

E. Genin on behalf of the ISYS group
European Gravitational Observatory

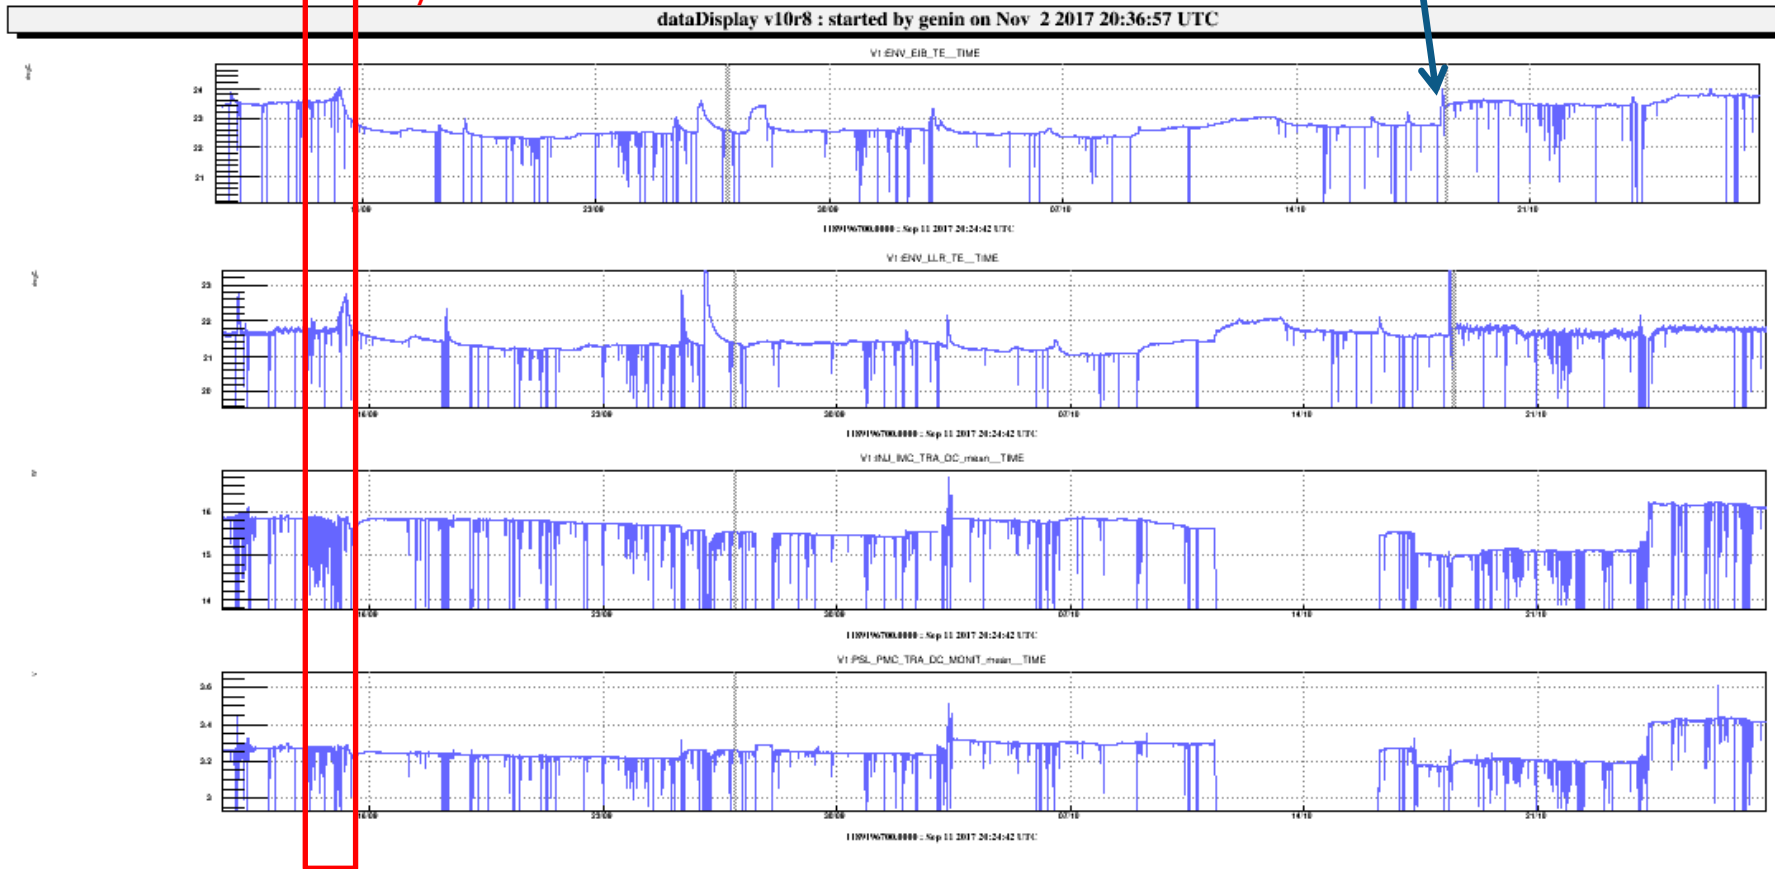
INJ air conditioning
system failure

The AC was back
on

INJ clean room air conditioning system: Major failure

- ❑ Switched off for 4 weeks starting from September 15
- ❑ We kept opened the doors separating the clean rooms from the laser lab to keep the temperature in the laser lab constant.
- ❑ We suffered a bit of misalignment of the PMC cavity and loss of PMC output power.

→ very worrying situation.

- ❑ The air ducts outside of the laser lab have been replaced.
→ the air conditioning is working again. We are back to standard conditions.

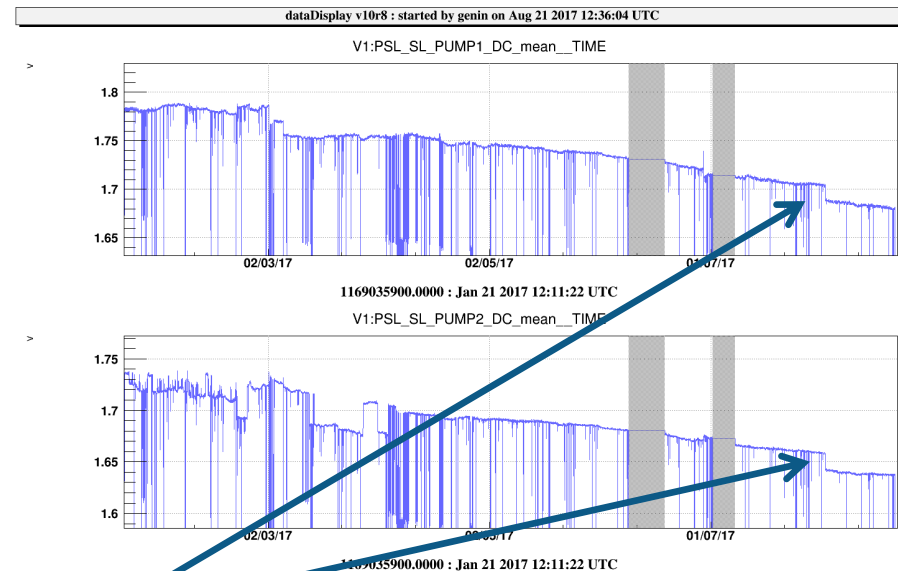
Pumping current decrease

- ❑ Slave laser pumping diodes (see entry #39259).
 - started in May 2017. In August we started to see some glitches and we had to reduce the current applied on the pumping diode to fix it (see entry #39005).

❑ We will have to substitute at least the slave laser pumping diodes (before O3 run)
→ after the laser system upgrade.

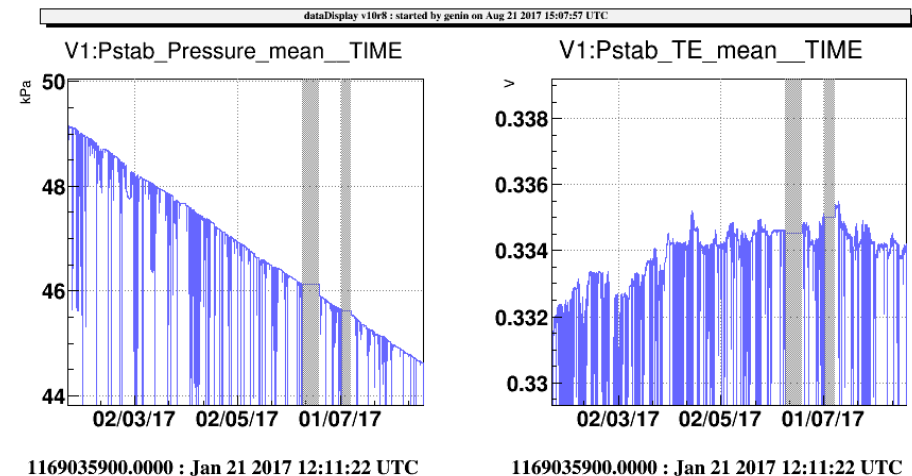
- ❑ Power stabilization electronics box leak (7.86 kPa/year). No effect on the temperature so far (see entry #39250).

❑ We need to fix the leak of the power stabilization electronics box (to be done during SIB1 intervention and during monolithic suspensions upgrade to minimize ITF down time). It will be done during the shutdown for the West arm MS installation (already inserted in the planning).

❑ The idea is to replace the currently used box by a spare one which has already been tested in air at Nice.

❑ We are preparing the box tests in a vacuum chamber in the EGO optics lab (this week).
