Compared analysis of payload failures

Helios Vocca &

Flavio Travasso

17/03/2016

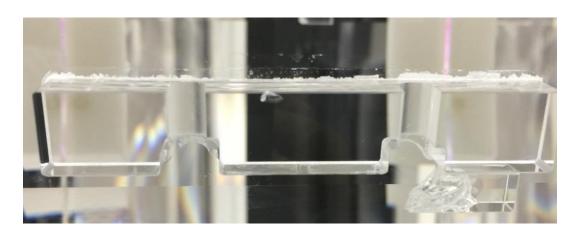
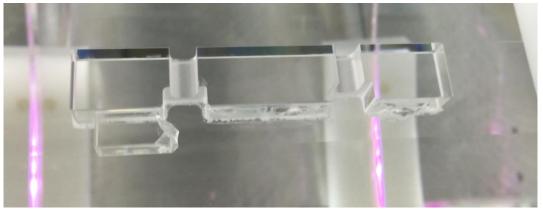
WI - Ears view after the crash

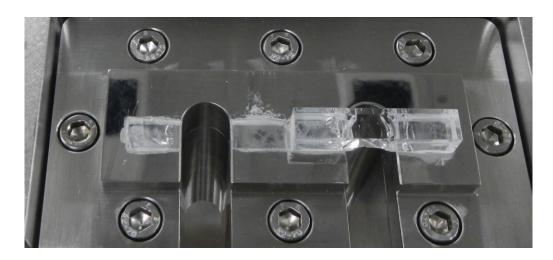
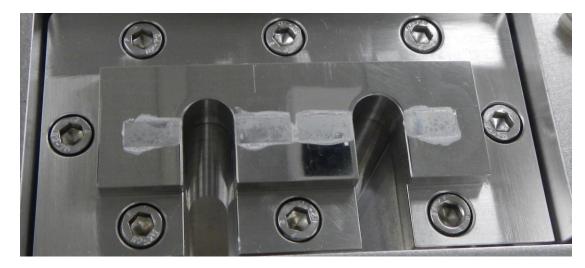
WI - Marionetta view after the crash

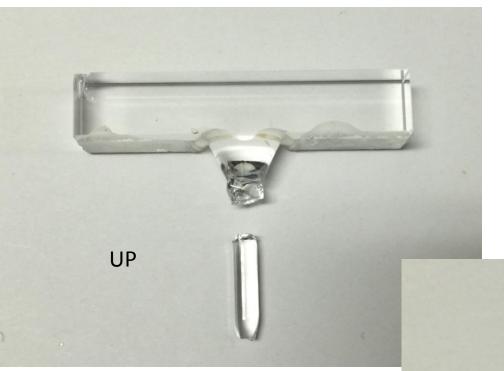
According to the data the crash begun from this fiber: it can be started from the lower cone (or at least from the upper welding...).

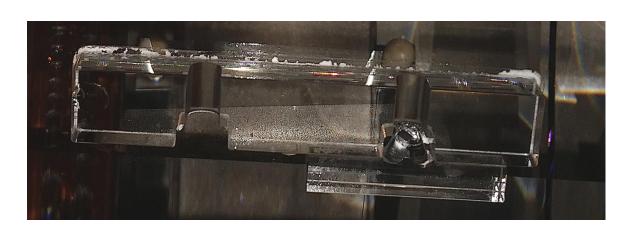
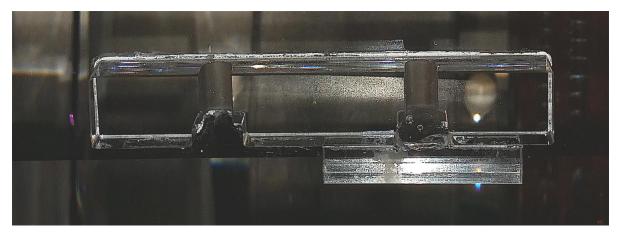
NI - Ears view after the crash

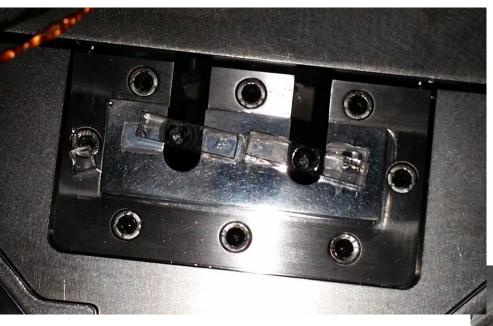
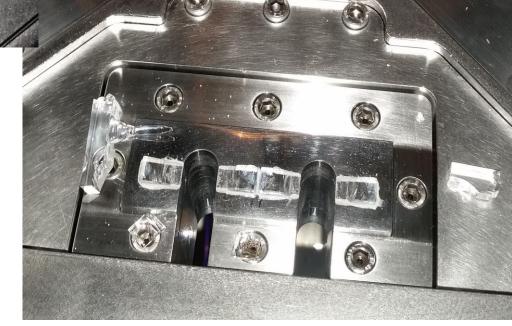
NI - Marionetta view after the crash

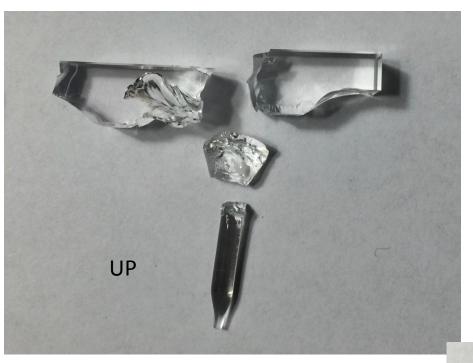
According to the data the crash begun from this fiber: it seems to be started from the lower cone that appears to be opened by a traction from the top, while the upper anchor crash has been caused by a pressure from the bottom to the top as a reaction.

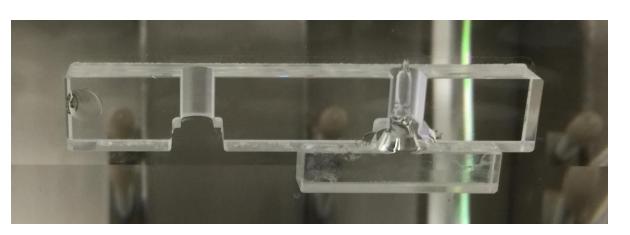
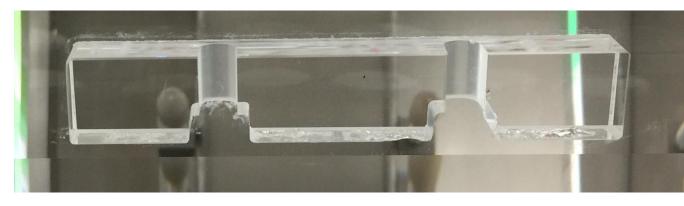
2° NI - Ears view after the crash

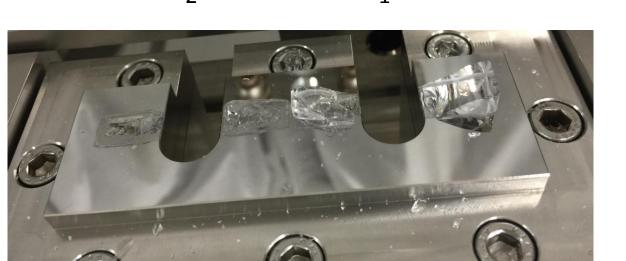
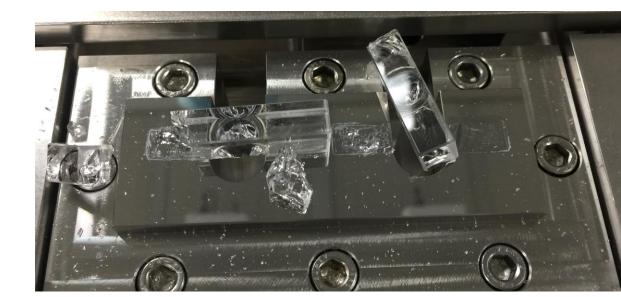
2° NI - Marionetta view after the crash

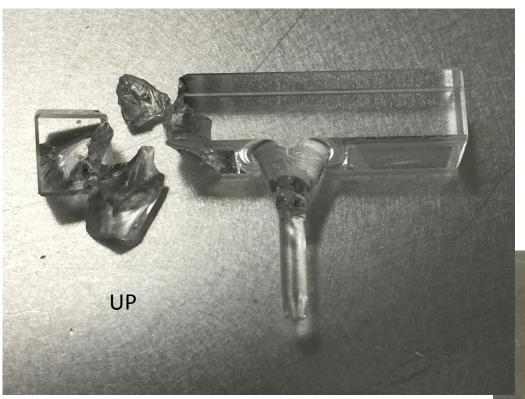
According to the position of the mirror after the crash, the break of the FS suspension begun from this fiber: the two anchor crashes have been caused by a compression force so from a release of energy started from the fiber.

In this suspension the anchors performed as expected.

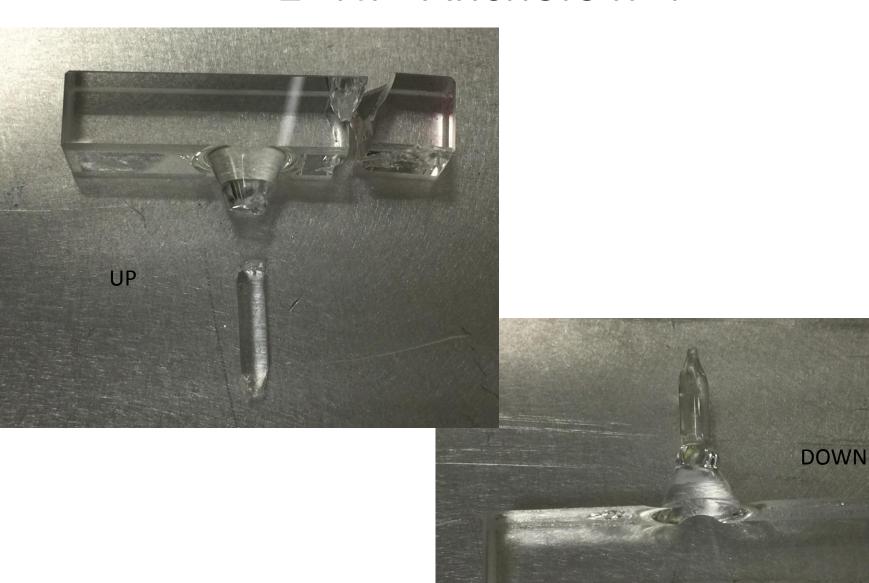
WI - DUMMY

The fiber 3 and 4 survived, while fibers 1 and 2 were broken!

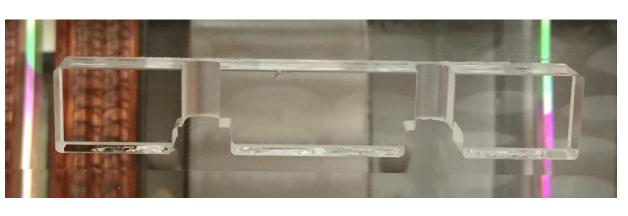
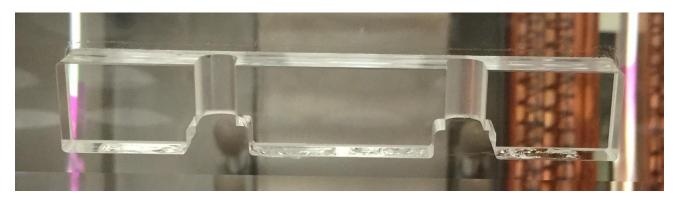
2° WI - Ears view after the crash

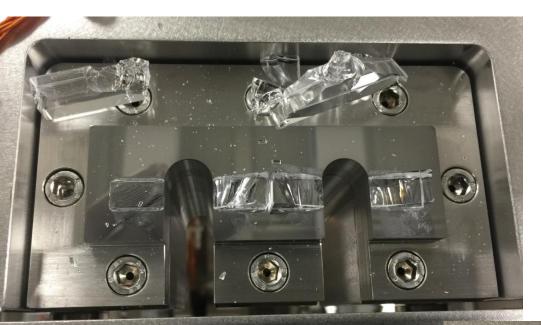
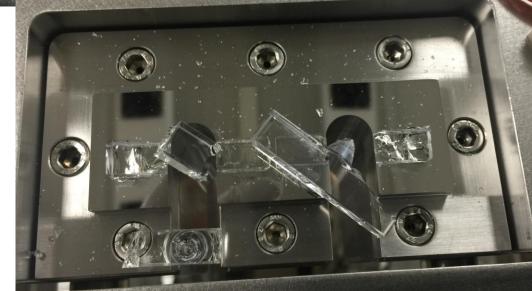
2° WI - Marionetta view after the crash

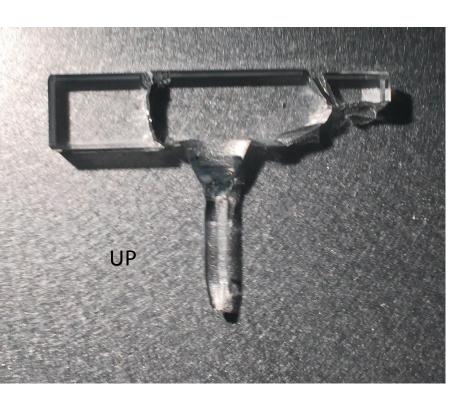
According to the data the crash begun from this fiber. The anchors performed as expected. The failure started at the level of the fiber (or at the level of the 3mm bar close to the welding).

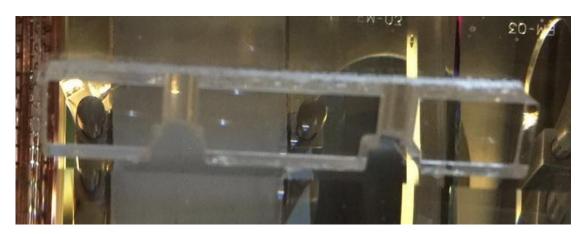
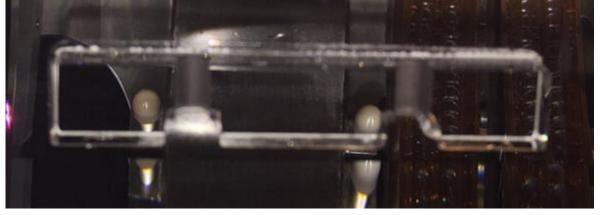
WE - Ears view after the crash

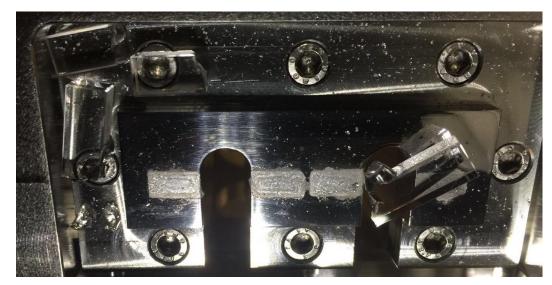
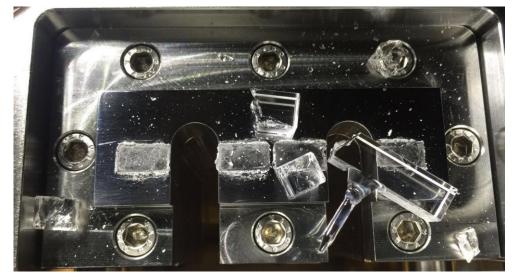
WE - Marionetta view after the crash

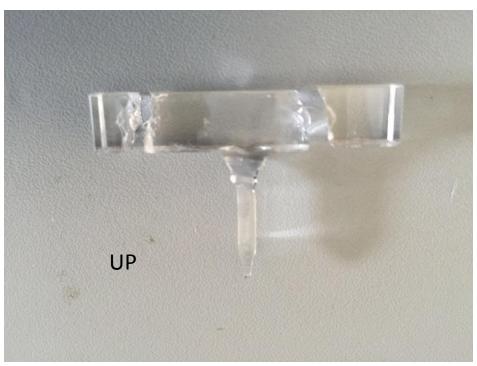
According to the data the crash begun from this fiber..it seems that the failure was induced by the fiber
