Compared analysis of payload failures

Helios Vocca

Flavio Travasso

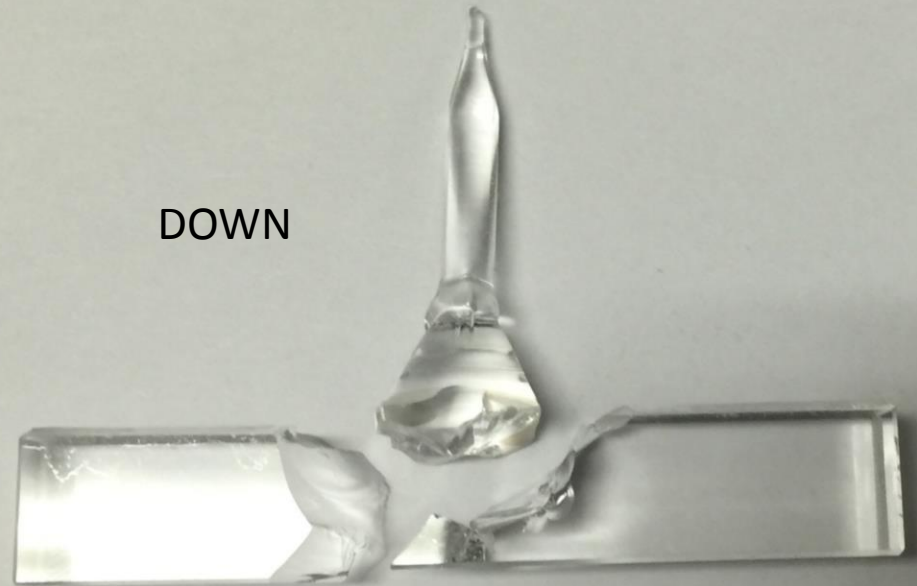
WI - Anchors n°3

According to the data the crash begun from this fiber: it can be started from the lower cone (or at least from the upper welding...).

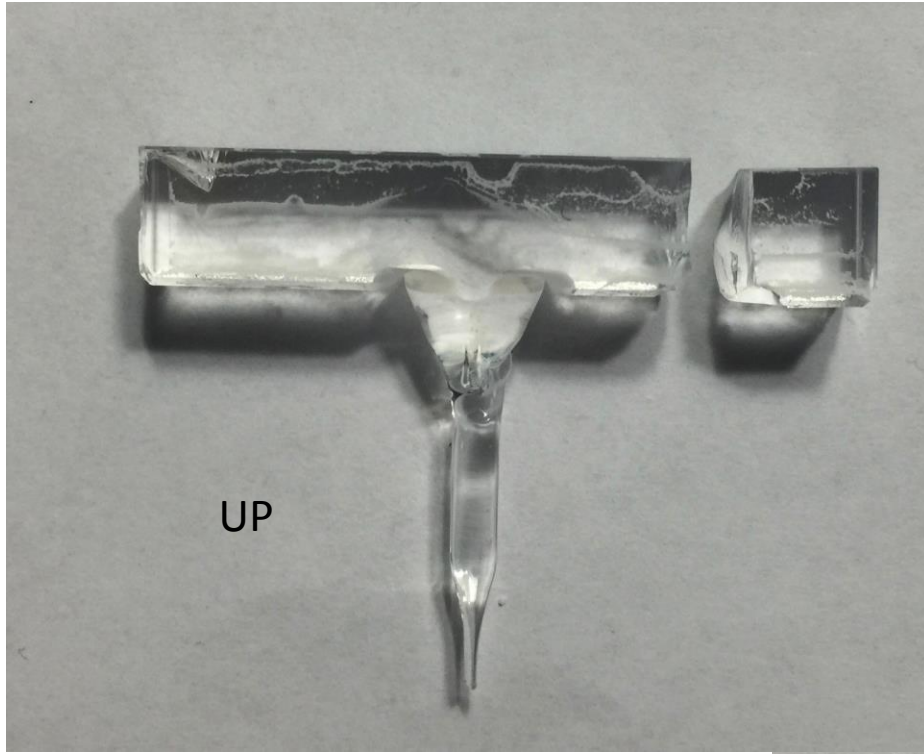
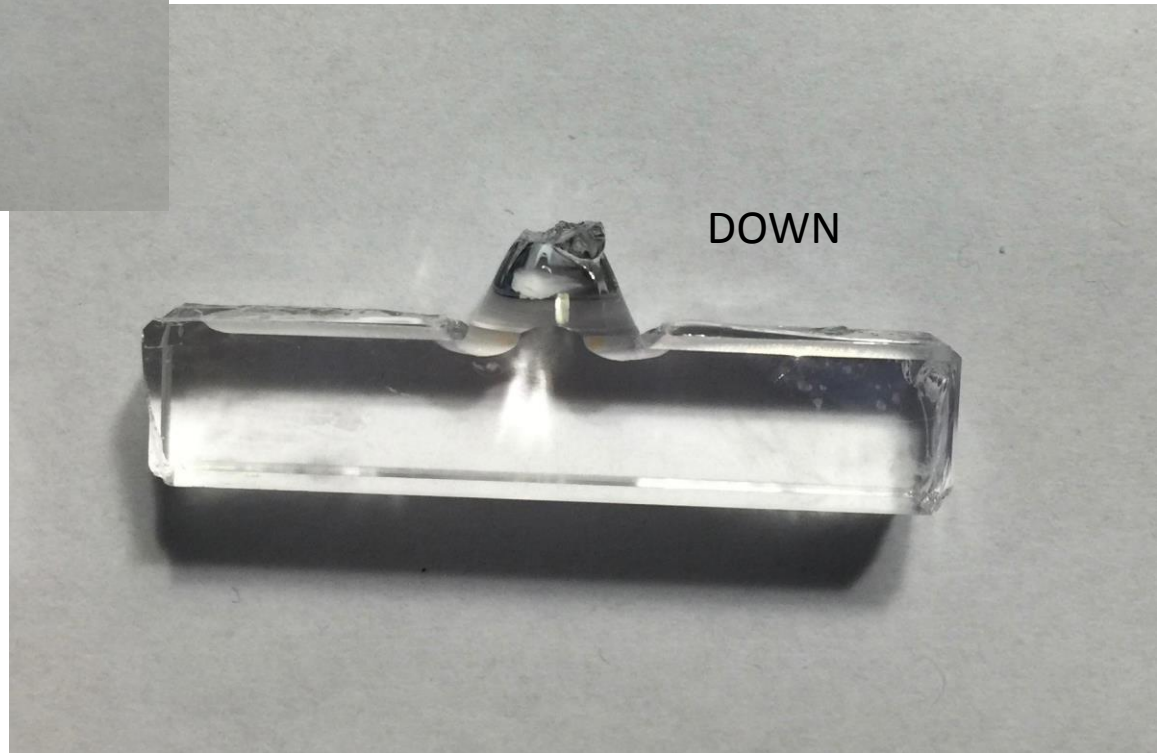
NI - Anchors n°2

According to the data the crash begun from this fiber

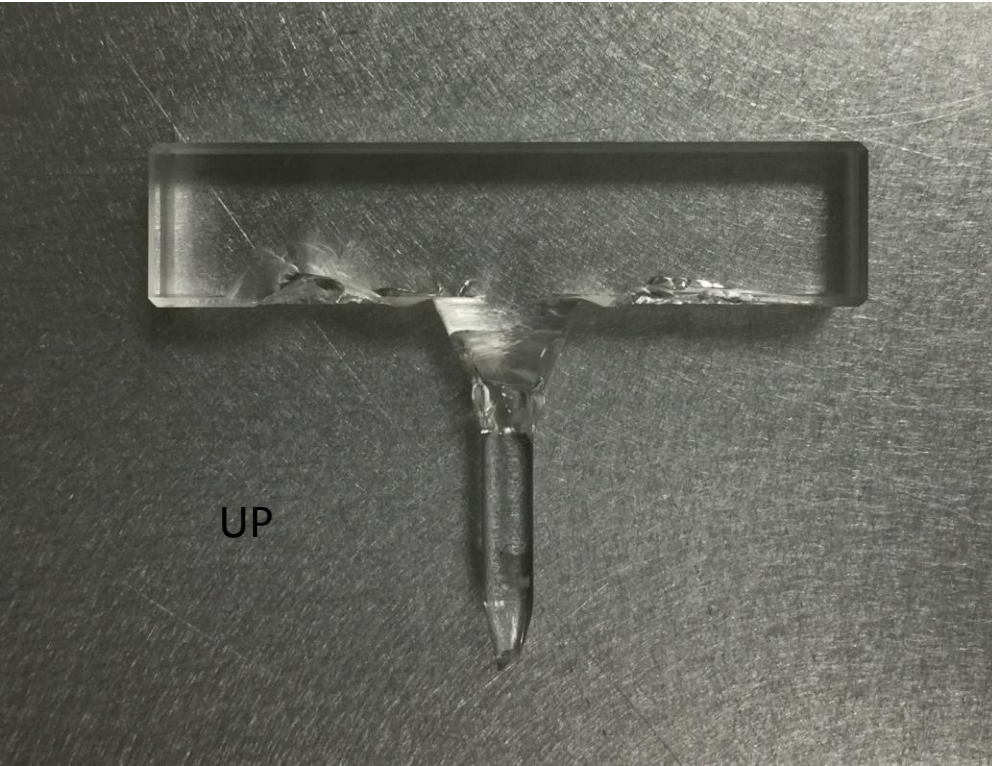
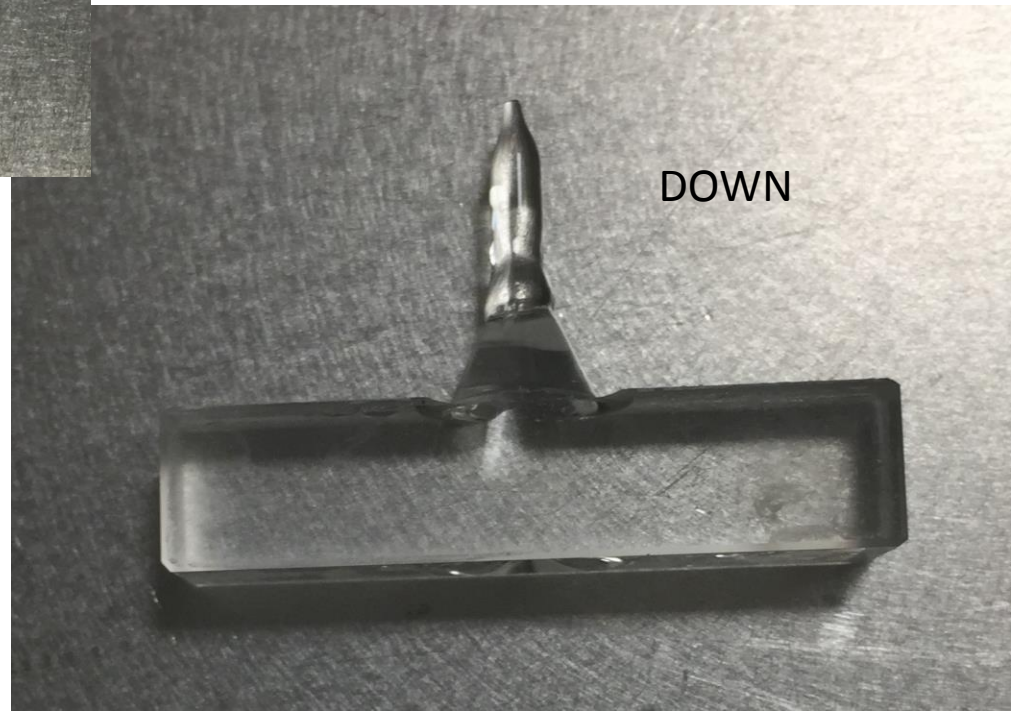
2° NI - Anchors n°2

According to the data the crash begun from this fiber

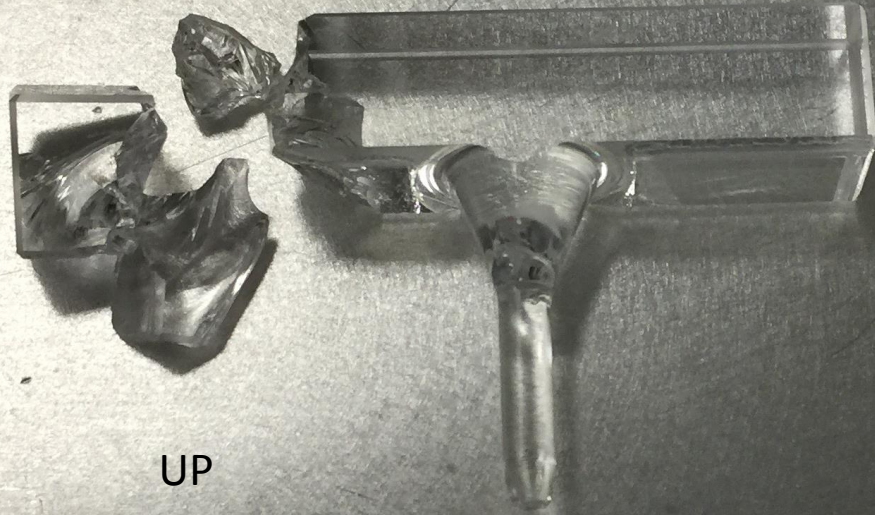
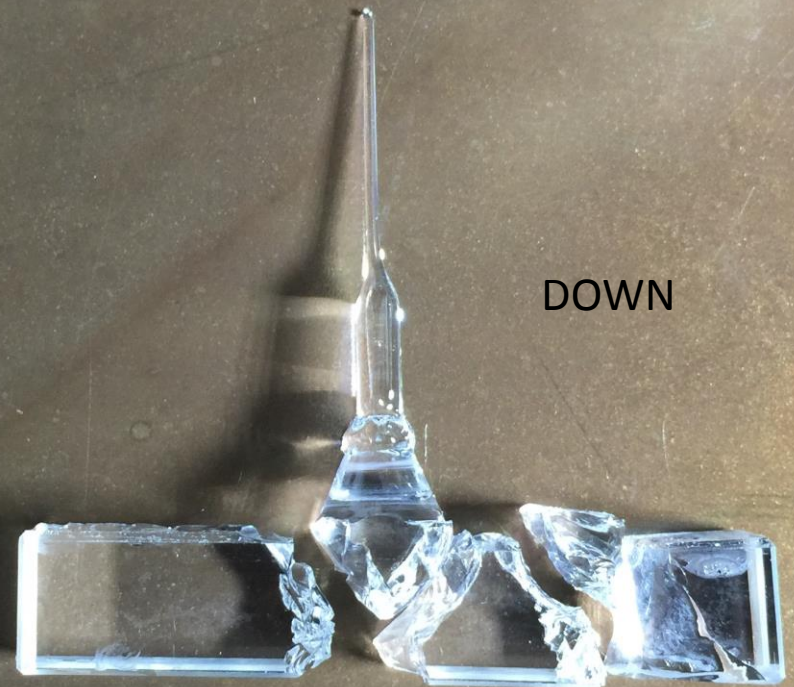
2° NI - Anchors n°3

In this suspension the anchors performed as expected.

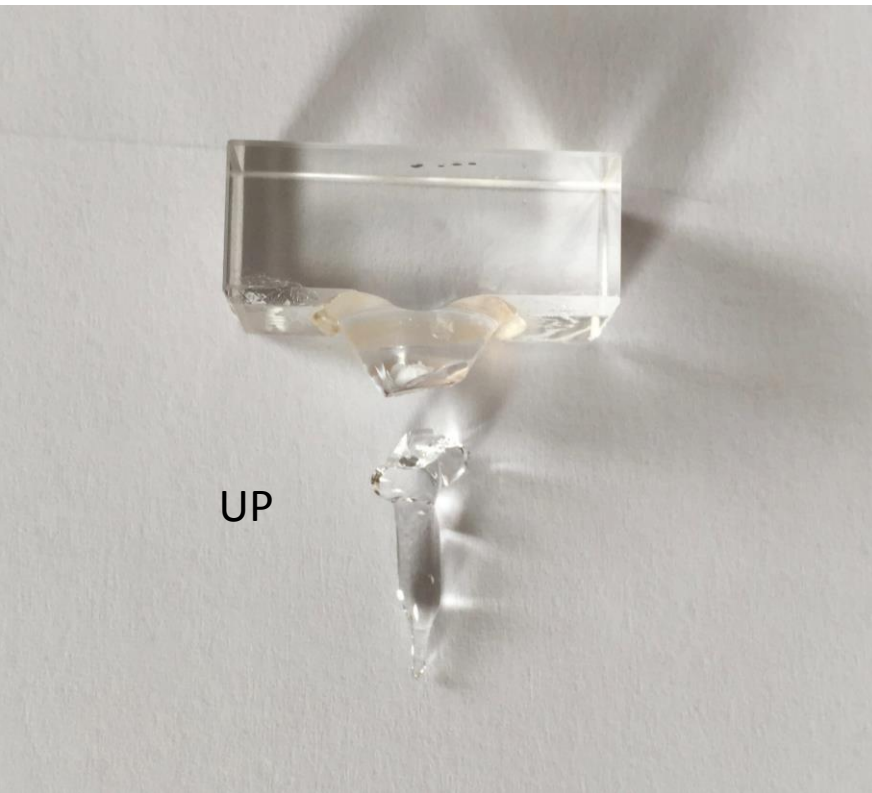
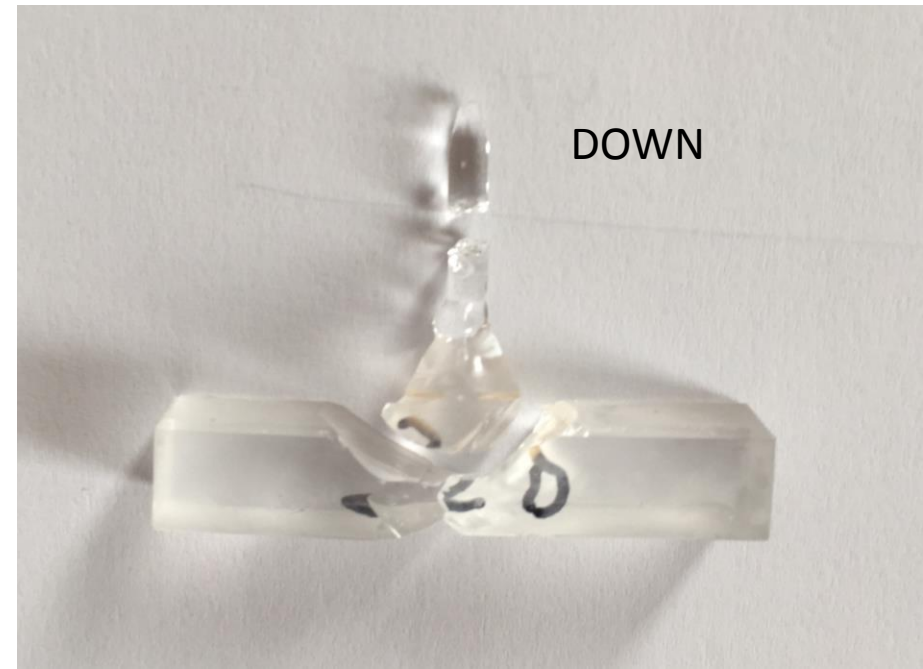
WI dummy- Anchors n°1

The fiber 3 and 4 survived,
while fibers 1 and 2 were
broken!

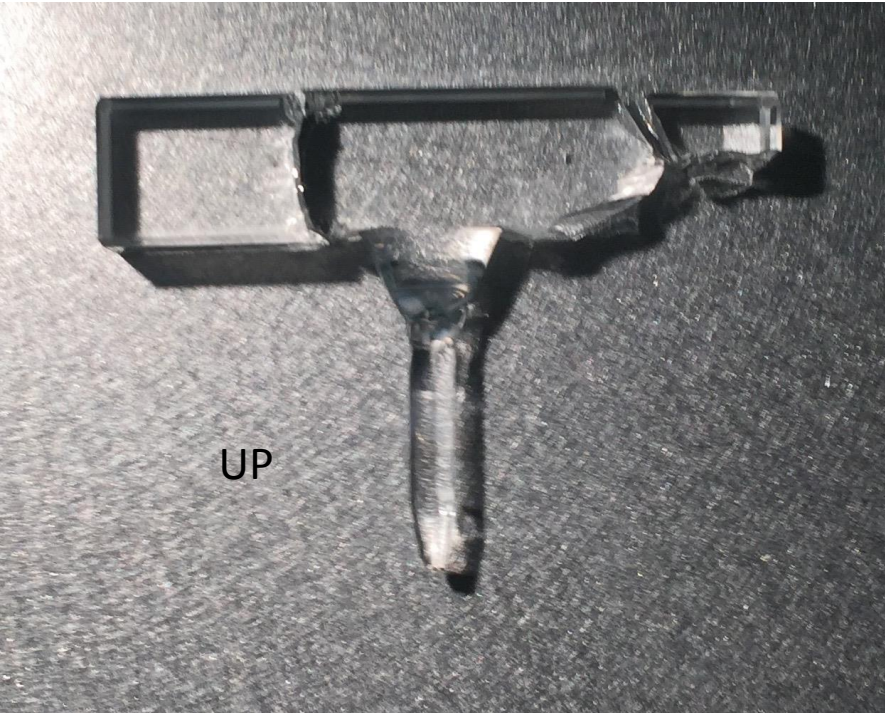
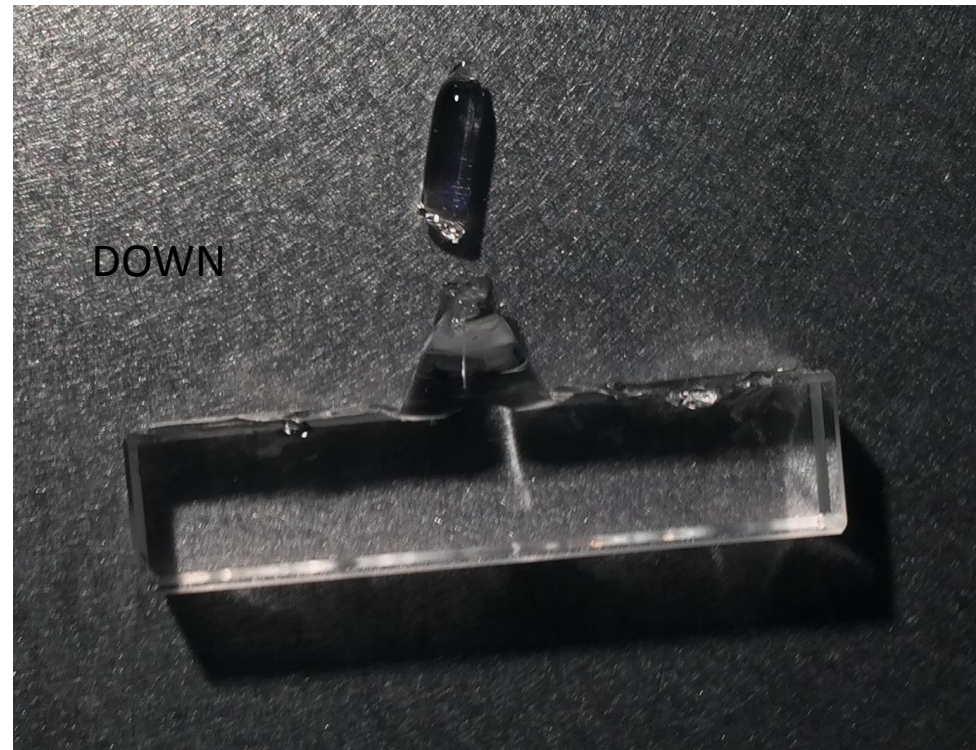
2° WI - Anchors n°3

According to the data the crash begun from this fiber. The anchors performed as expected. The failure started at the level of the fiber (or at the level of the 3mm bar close to the welding).

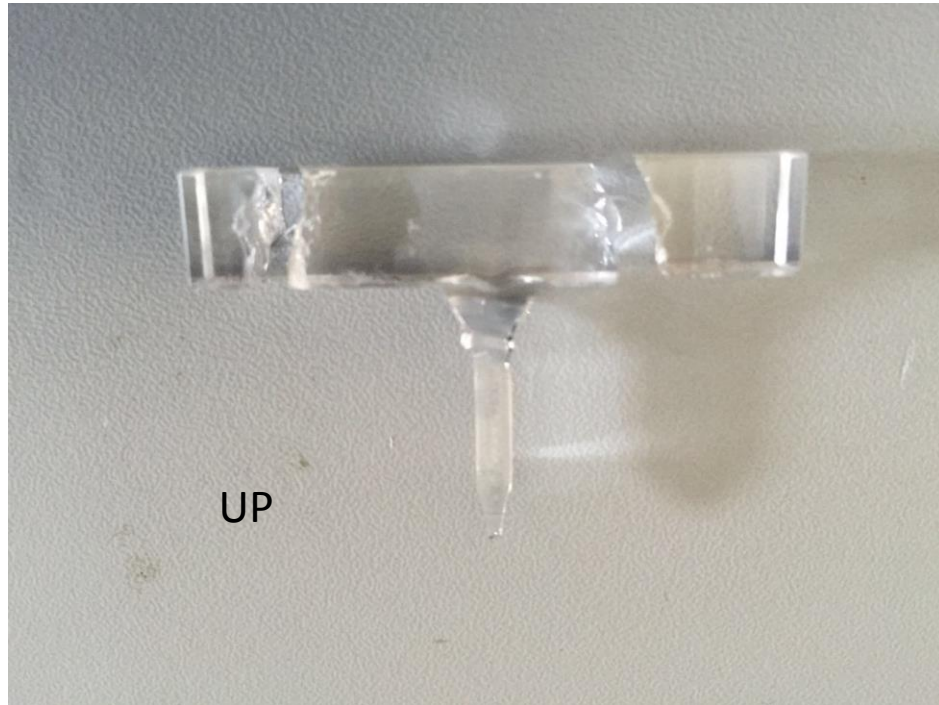
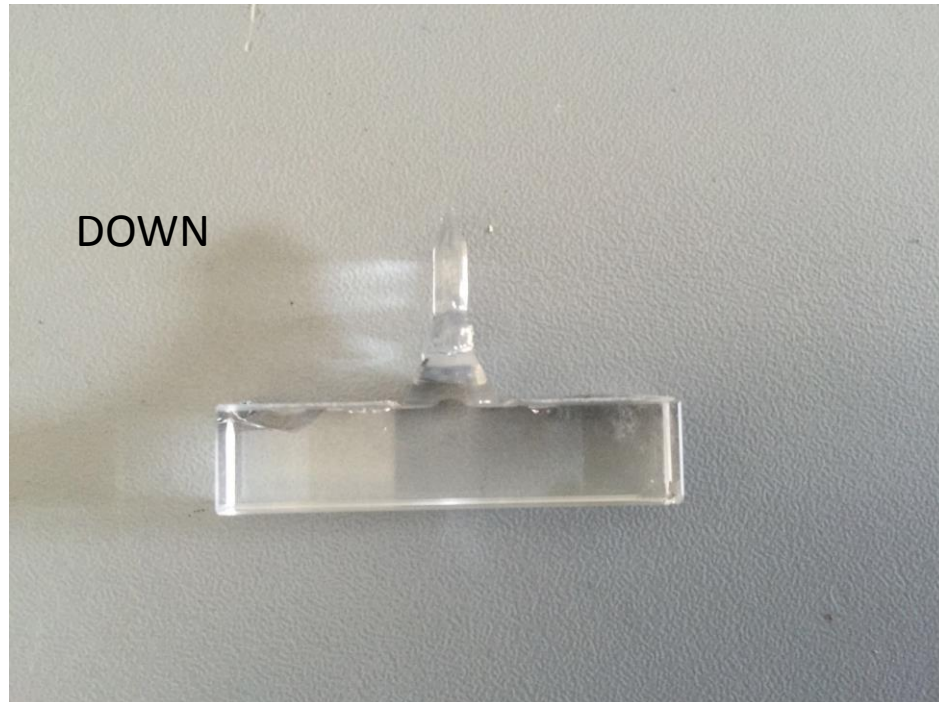
WE - Anchors n°3

According to the data the crash begun from this fiber..it seems that the failure was induced by the fiber

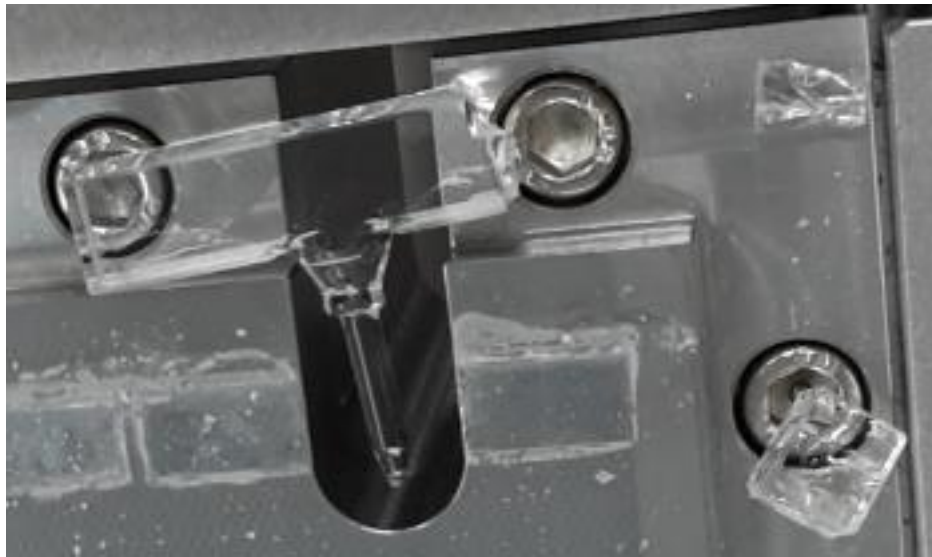
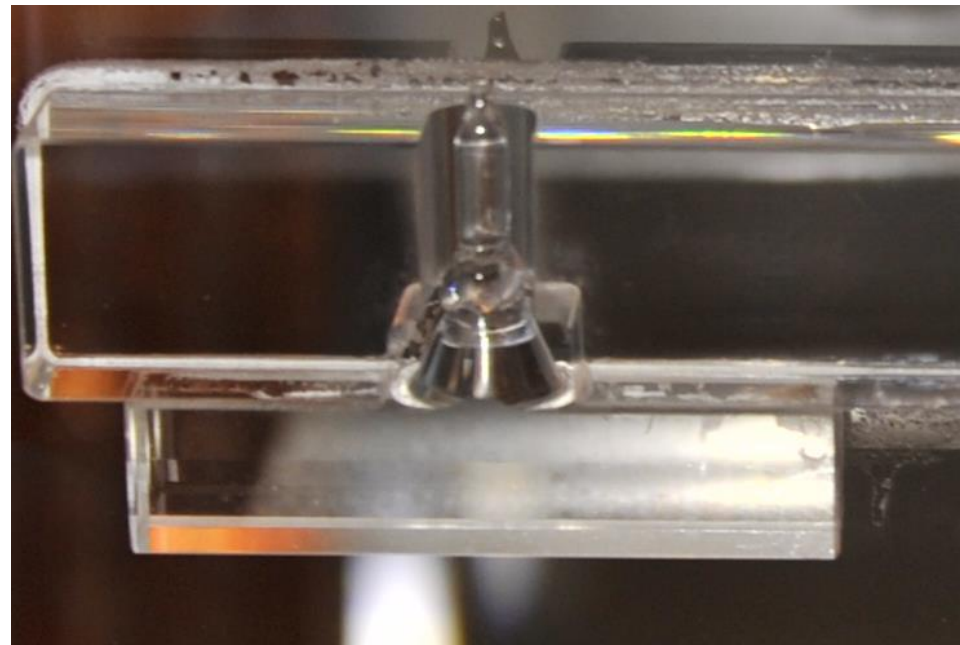
NE - Anchors n°1

(Almost) intact on
the Marionetta

Intact on the Ear

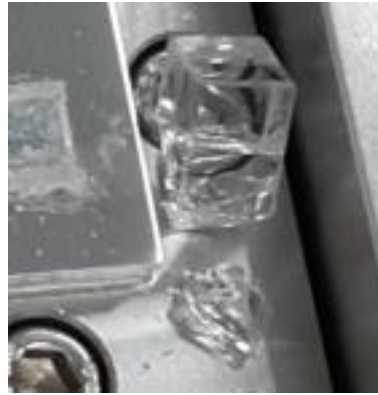
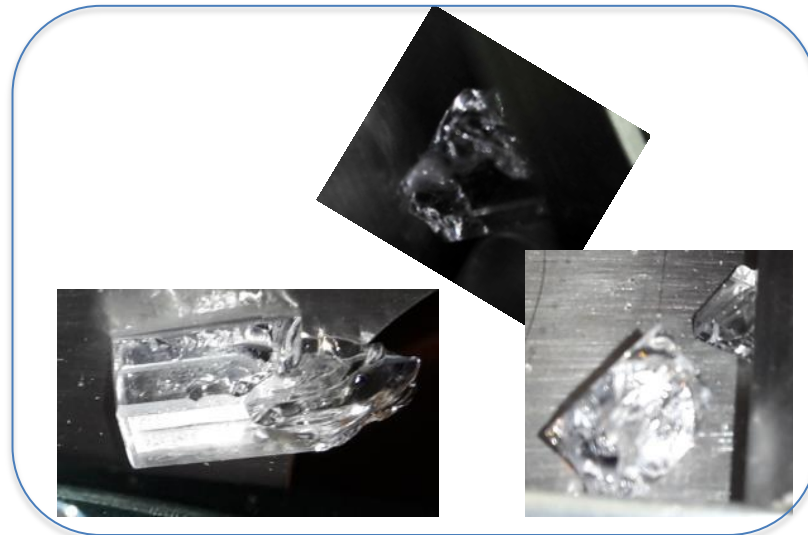
NE - Anchors n°2

Felt on the flange

The other parts broken on the marionetta

According to the data the failure started from this fibre caused with high probability by the fibre itself, in a region far from the bottom (because of the big energy released on the lower anchor to brake it on the ear and then on the cradle).

Parts broken below the mirror, on the cradle. The breakings appears induced by the impact.

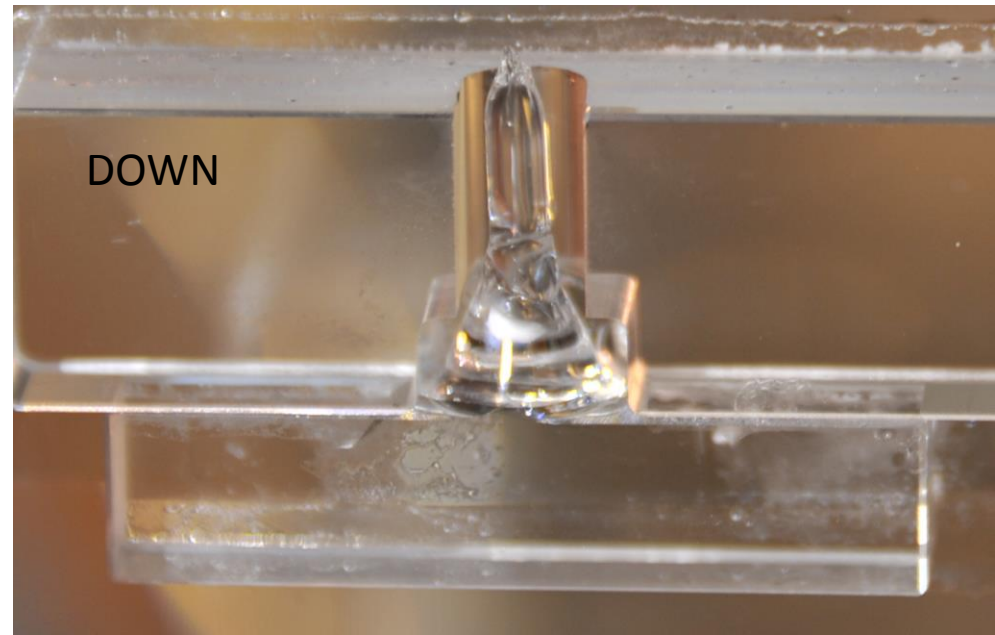
NE - Anchors n°3

Intact on the
Marionetta

Intact on the Ear

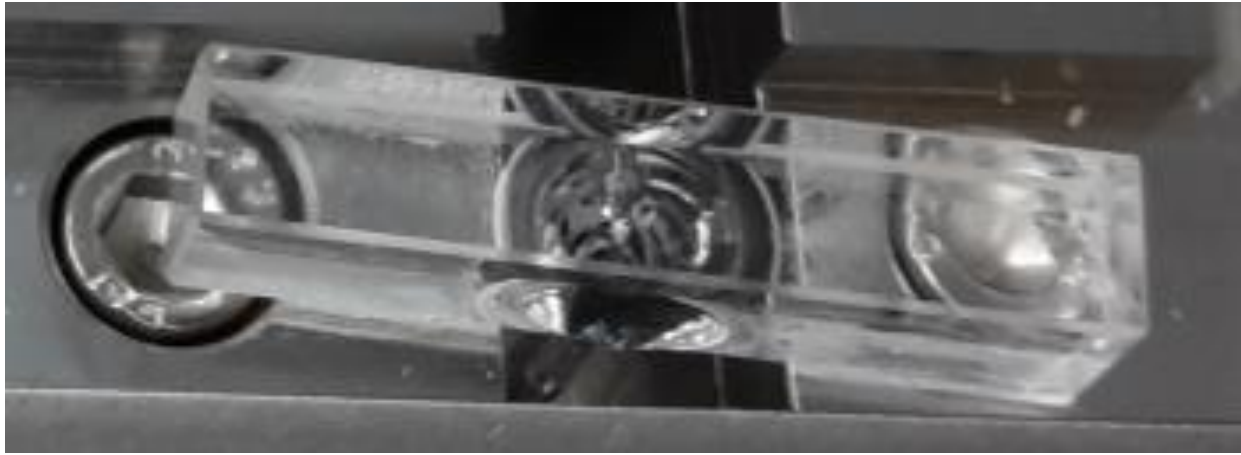
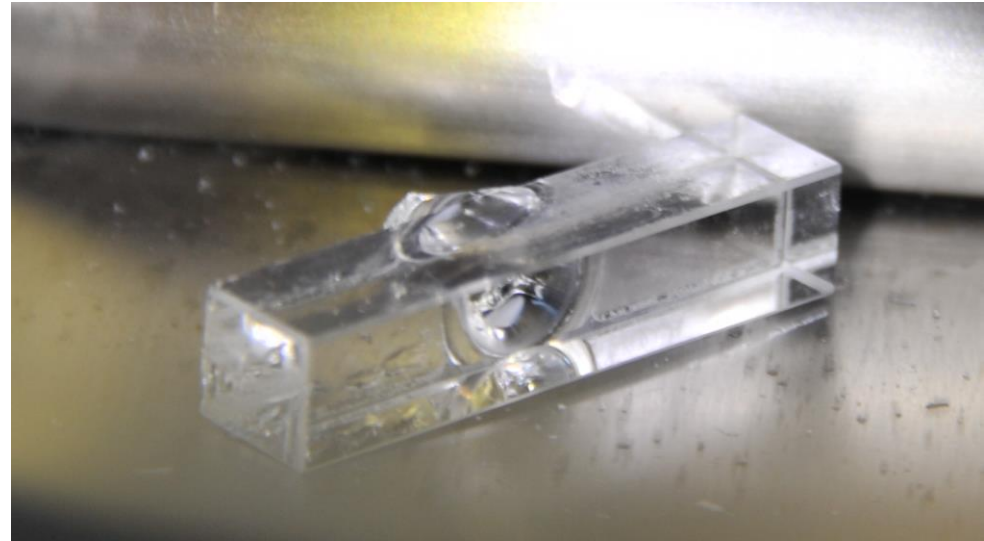
NE - Anchors n°4

Intact on the Marionetta

Intact on the cradle below the mirror, with the exception of the bar probably because of the impact on it.
