Scattered light noise mitigation in DET

R. Gouaty of behalf of DET sub-system (but also SBE, SLC and many others)

- What has been done during AdV installation and commissioning
- What is planned for AdV+
- What is missing

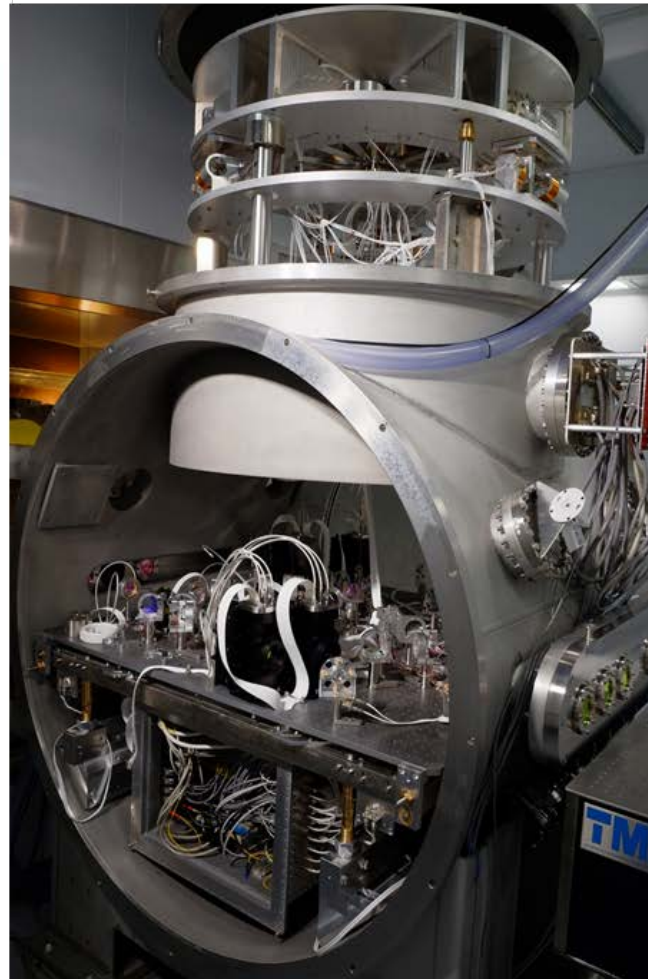
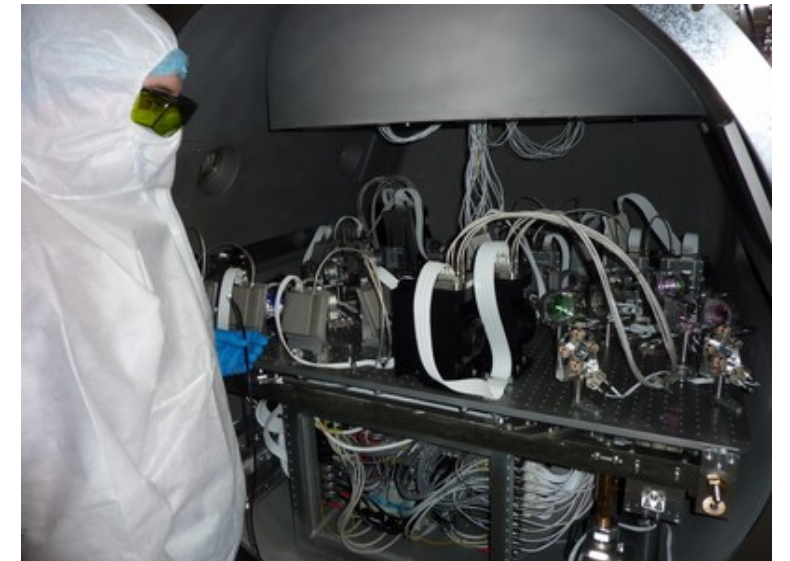
Seismic and acoustic isolation of optical benches (AdV design)

- Optical benches hosting the main photodiodes (B1, B2, B4, B5, B7, B8) all suspended and placed in vacuum.

- Photodiodes and preamplifier inside air-tight boxes
- Bench with integrated electronics to avoid too many cables going through the suspension and mechanical short-circuit

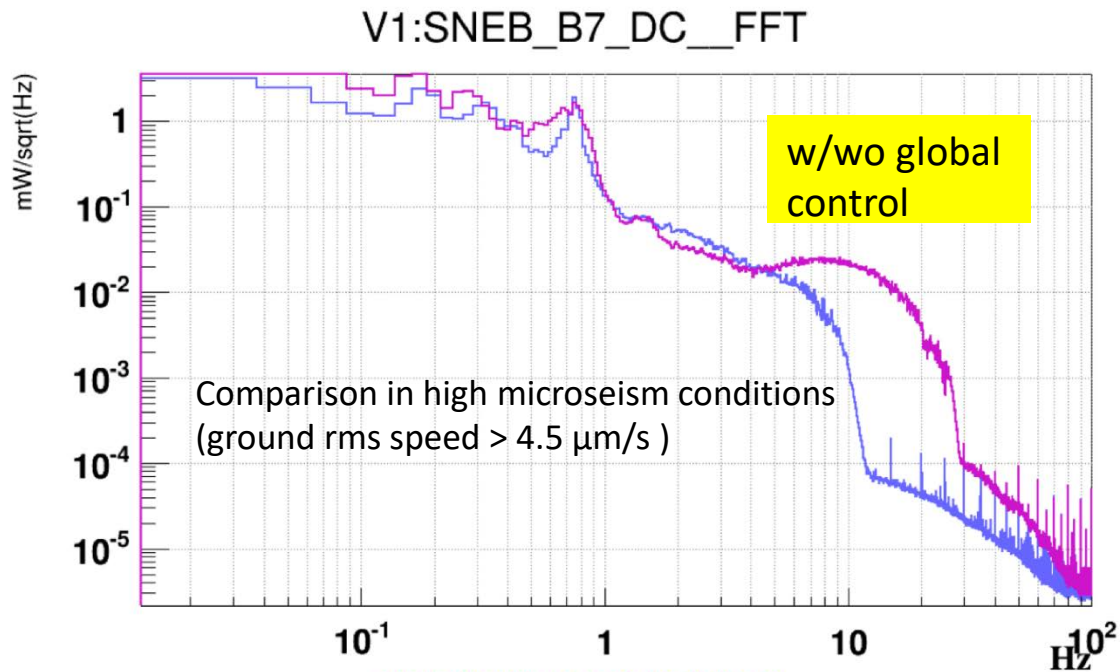
Reducing bench motion at low frequency (O2-O3 commissioning)

- SDB2 tracking loop (used during O2 and O3):
 - SDB2 is tracking in Z direction (beam axis) the position of SDB1 around the micro-seismic peak
 - The error signal is the difference between SDB1_LC and SDB2_LC horizontal LVDTs
- SNEB/SWEB global control (implemented by SBE during O3):
 - Make SNEB and SWEB tracking the nearby SAT.

1235797420.0000 : Mar 5 2019 05:03:22 UTC
 1238441620.00 : Apr 4 2019 19:33:22 UTC dt:40.00s nAv:100

From VIR-0936A-19, A. Bertolini

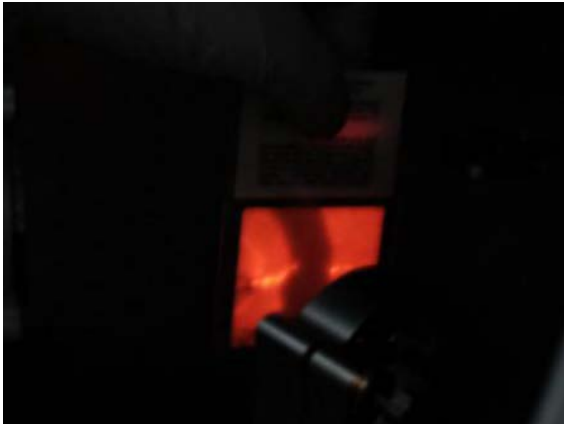
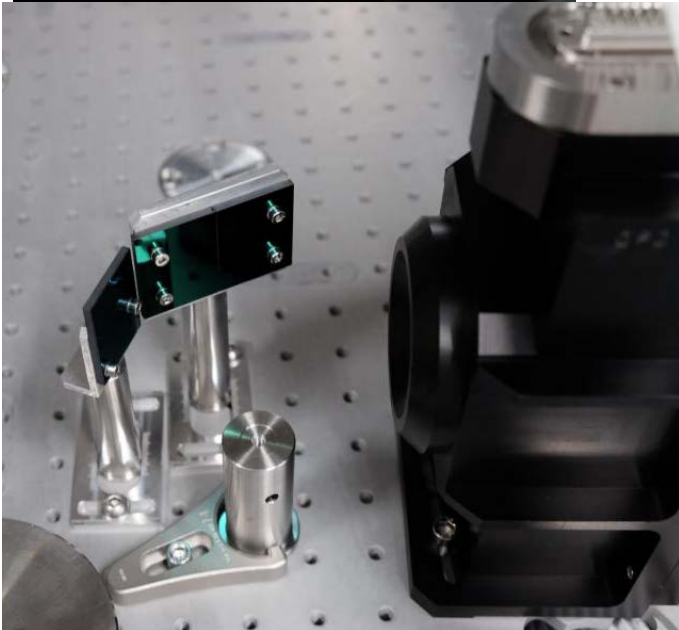
Dealing with the reflections of quadrant AR surface (O2 commissioning)

- Scattered light observed around the reflection of the B8 quadrants in February - April 2017 (logbook 36637, 37215)
- Solved by placing absorbing glass beam dumps in reflection of the quadrants (B8, B2, B1p, and more recently on B7)

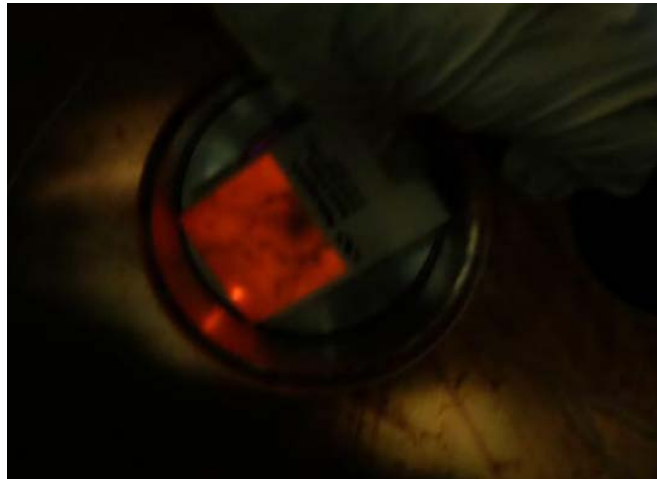
Dealing with the reflections of beam splitters AR surface (O3 commissioning) 2/2

- During SDB1 bench inspection: Found ghost beam hitting metallic ring inside B1p minilink
- Beam is residual reflection on AR surface of B1p pick-off 98.5% reflective mirror ($\sim 1\mu\text{W}$ in dark fringe)
- Absorbing glass beam dump added in front of the minilink

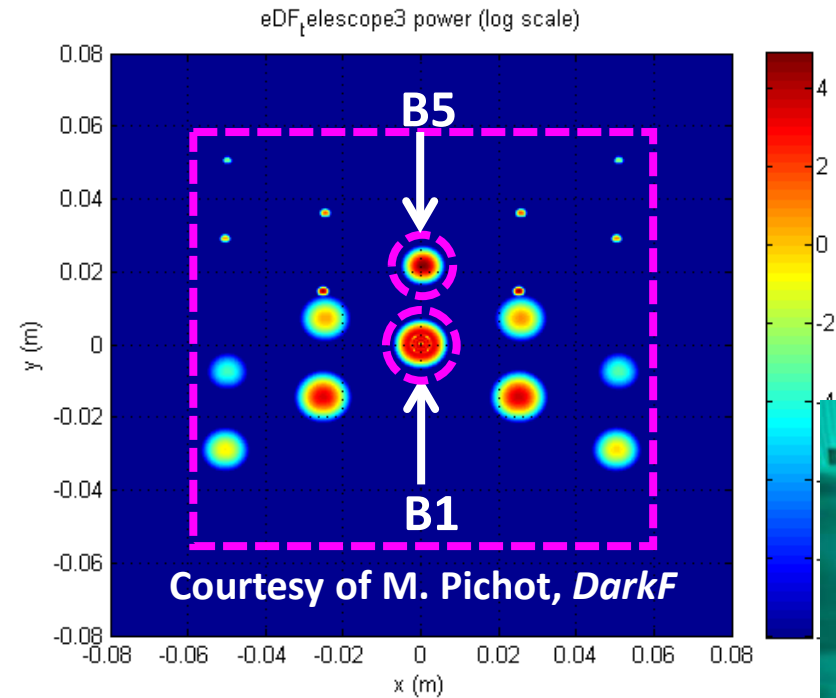
Dealing with ITF secondary beams (AdV installation + commissioning): SDB1

- Optical simulations (DarkF, Zeemax) predicting the position of secondary beams coming from ITF AR surfaces (CP, POP, BS)
- Designed diaphragm on SDB1 to dump these secondary beams
- Secondary beams (CP reflections) found on the diaphragm at expected positions

Found weak secondary reflections from CP as expected

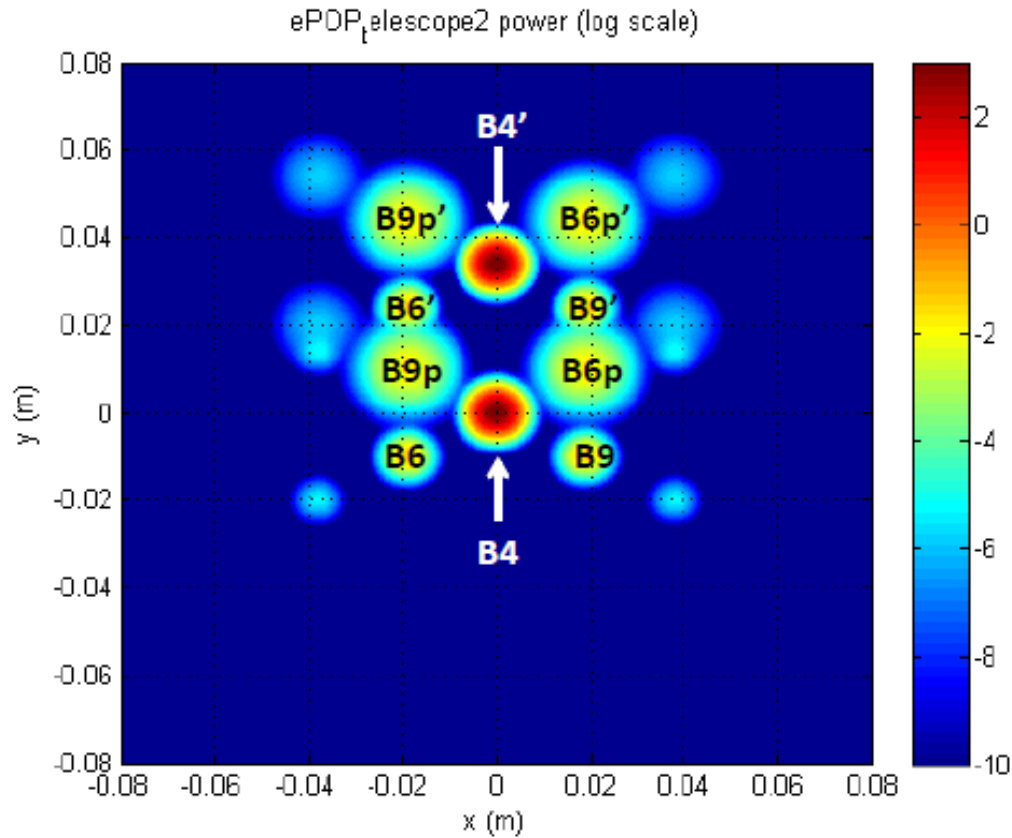
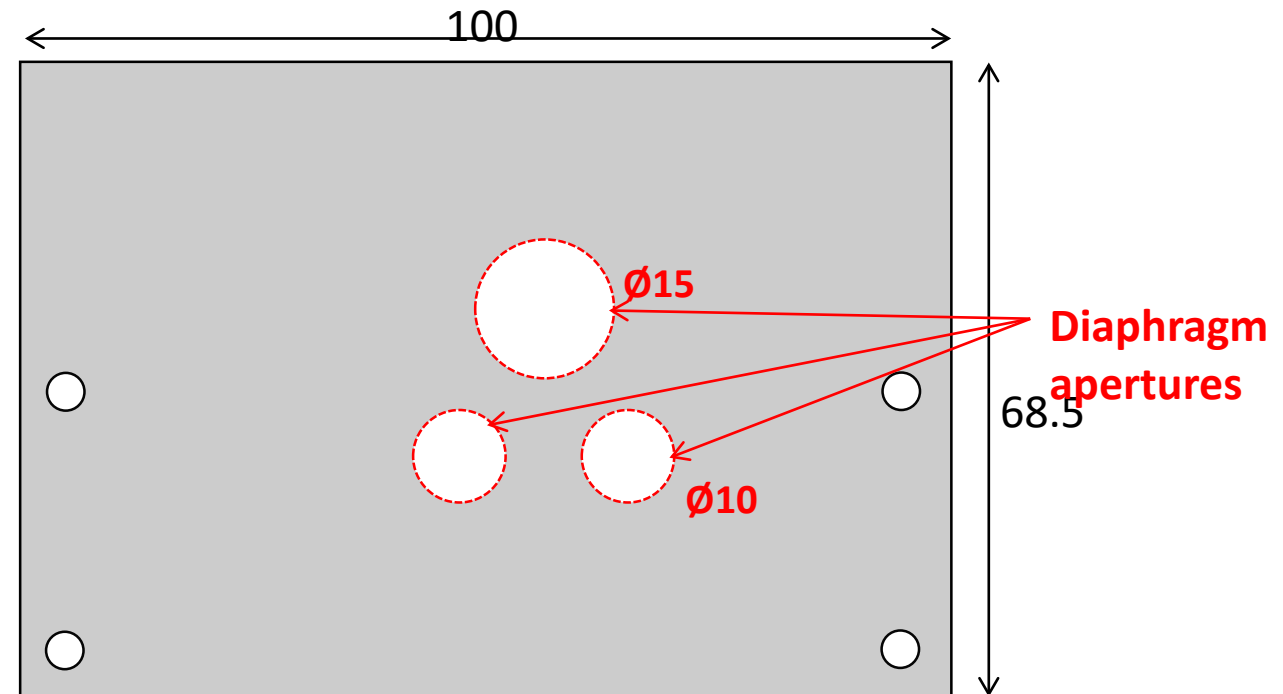
Dealing with ITF secondary beams (AdV installation): SPRB

- Designed diaphragm on SPRB to dump secondary beams coming from CP and second POP surface reflections

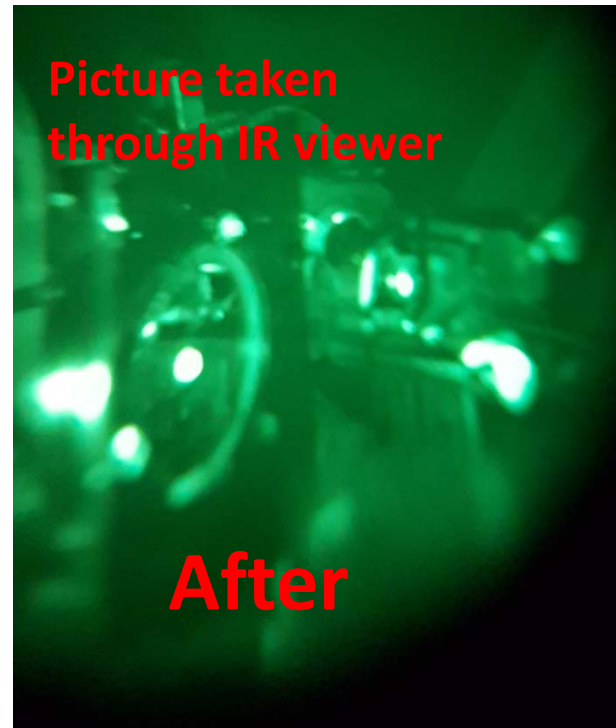
Absorbing uncontrolled scattered light on SDB1 (O3 commissioning)

- SDB1 inspections showed large areas of scattering on the mount of the 3 in dichroic mirror (placed at the output of the telescope parabolic mirrors)
- Situation improved by installing diaphragm made of mirror polished steel

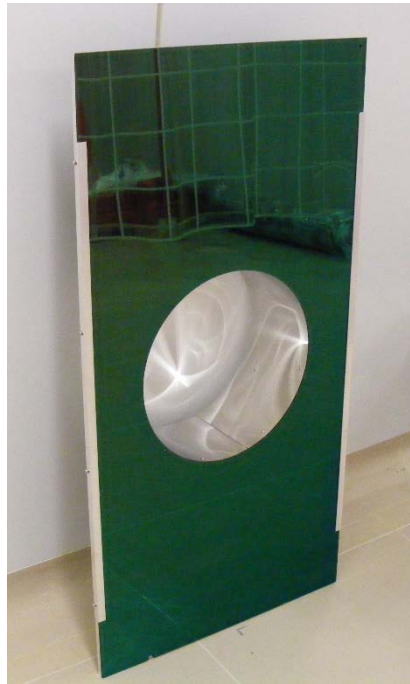
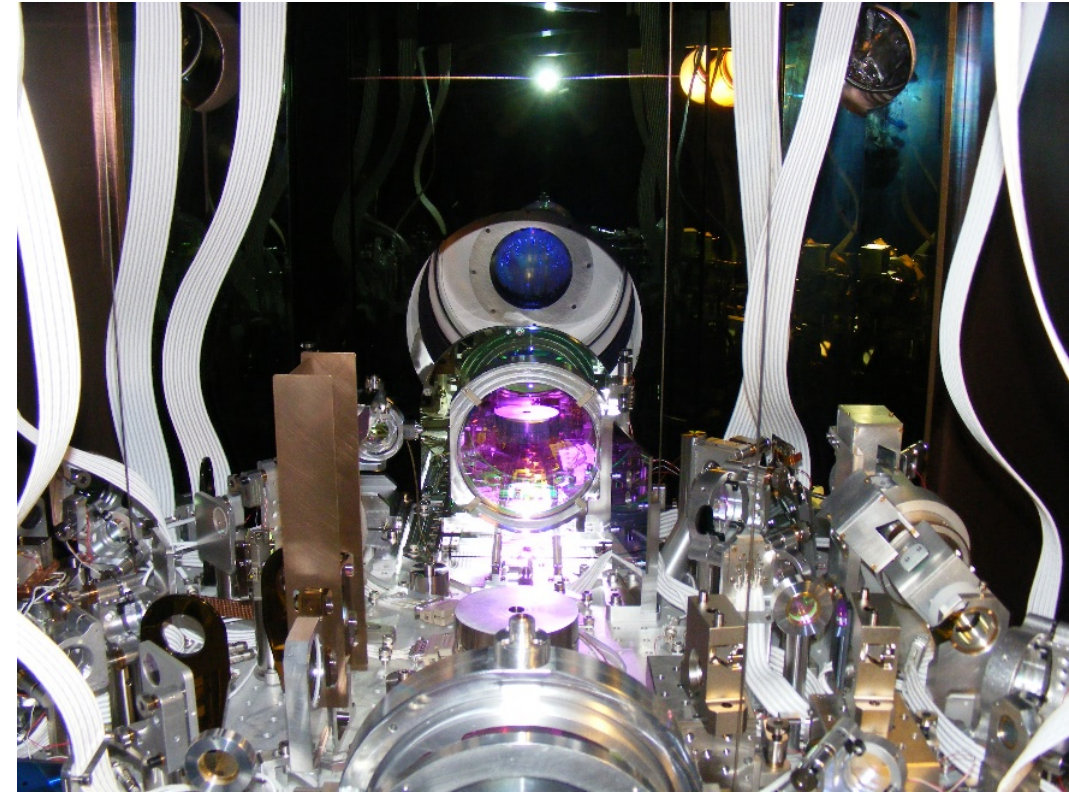
Absorbing uncontrolled scattered light on SDB1 (AdV design)

- Mirror polished steel diaphragm designed and installed at the SDB1 input (in front of the MMT meniscus lens)
- Glass baffles installed at the west flange of SDB1 tower (SLC)

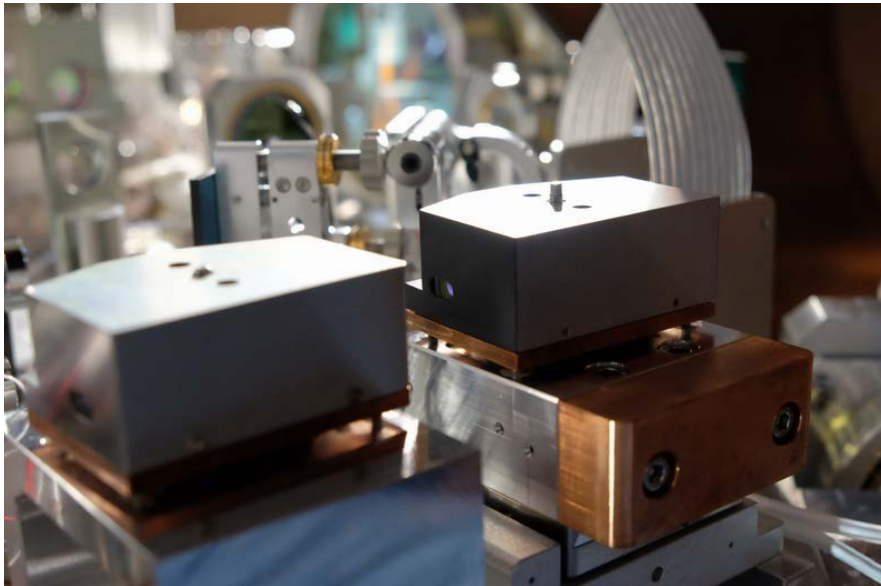
Absorbing OMC scattered light (O3 commissioning)

- Adv OMC surfaces roughness ~ 0.3 nm RMS and $F = 120 > 1\%$ of scattering losses per cavity
- OMC aluminium protective covers treated with Anoblack-EC (electrolytic blackening using inorganic metallic salts)
- Installed during O3 commissioning:
 - Absorb part of the light scattered by the OMC
 - Prevent the scattered light coming from other components to couple with the OMC

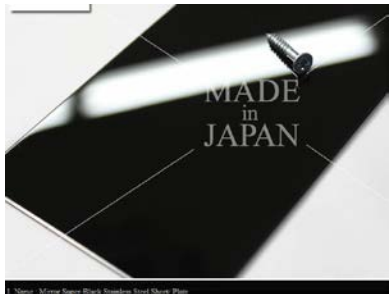
Adding diaphragms in front of dark fringe mode matching parabolic mirrors (3/3)

- Mechanical design of diaphragms optimized to mitigate vibrations and minimize weight: first resonance above 250 Hz
- Solution foreseen to attach steel mirror plates > stainless steel screws with « superblack » deposit
> Electrolytic Chemical Colored Stainless Steel

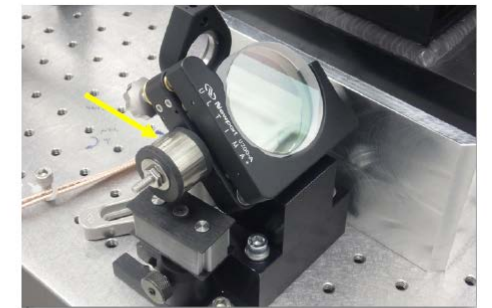
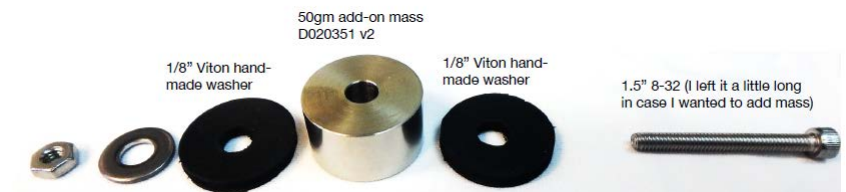
- Further improve and generalize the relative controls between benches and ITF mirrors
- Improve robustness of the optical mounts and feet
 - Requires mechanical simulation
 - Lower beam axis height whenever possible
- Damp main optical mounts resonance by attaching damping weights (with viton washer) : already done in LIGO
<https://alog.ligo-wa.caltech.edu/aLOG/index.php?callRep=46494>
