Compared analysis of payload failures

Helios Vocca
&
Flavio Travasso

17/03/2016

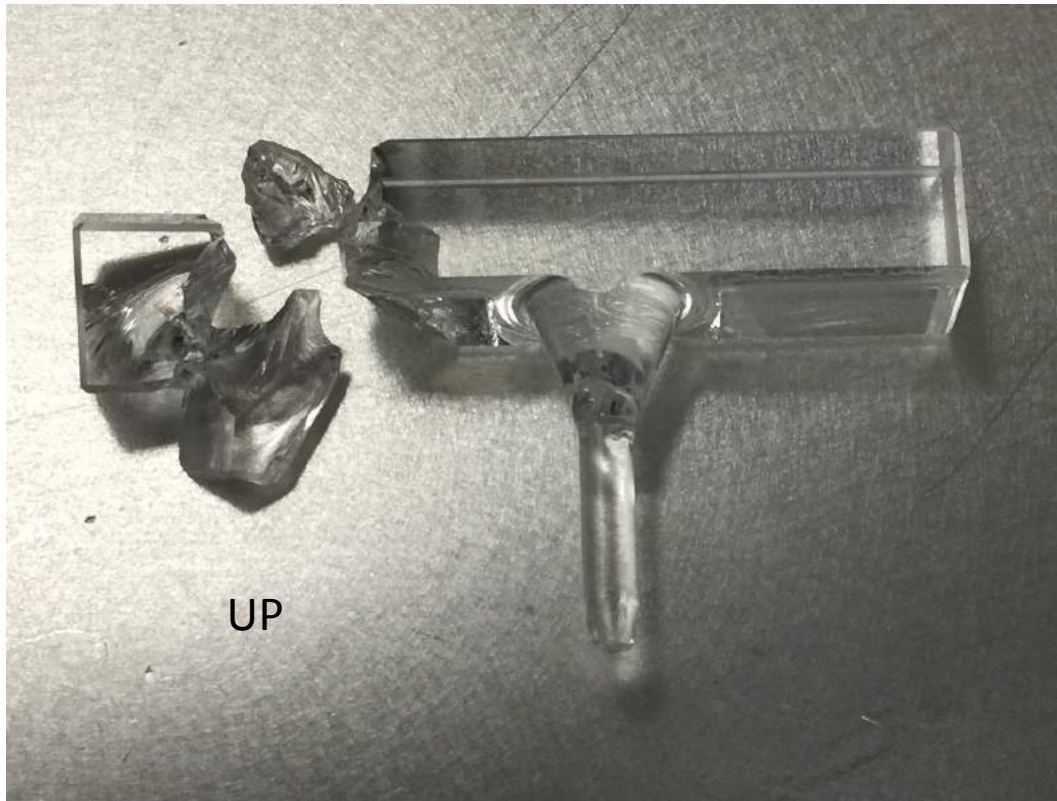
2° NI - Anchors n°3

According to the position of the mirror after the crash, the break of the FS suspension begun from this fiber: the two anchor crashes have been caused by a compression force so from a release of energy started from the fiber.

In this suspension the anchors performed as expected.
