Compared analysis of payload failures

Helios Vocca
&
Flavio Travasso

17/03/2016

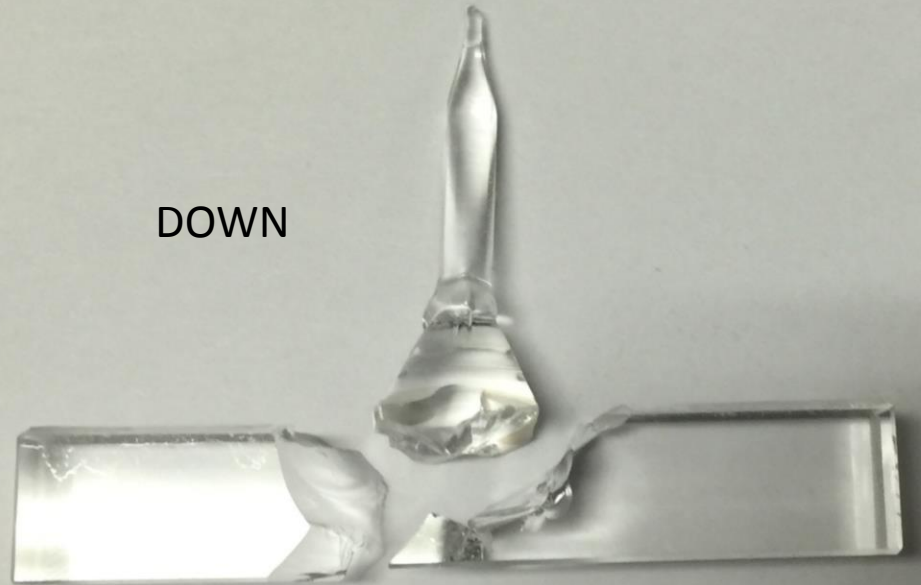
WI - Anchors n°3

According to the data the crash begun from this fiber: it can be started from the lower cone (or at least from the upper welding...).

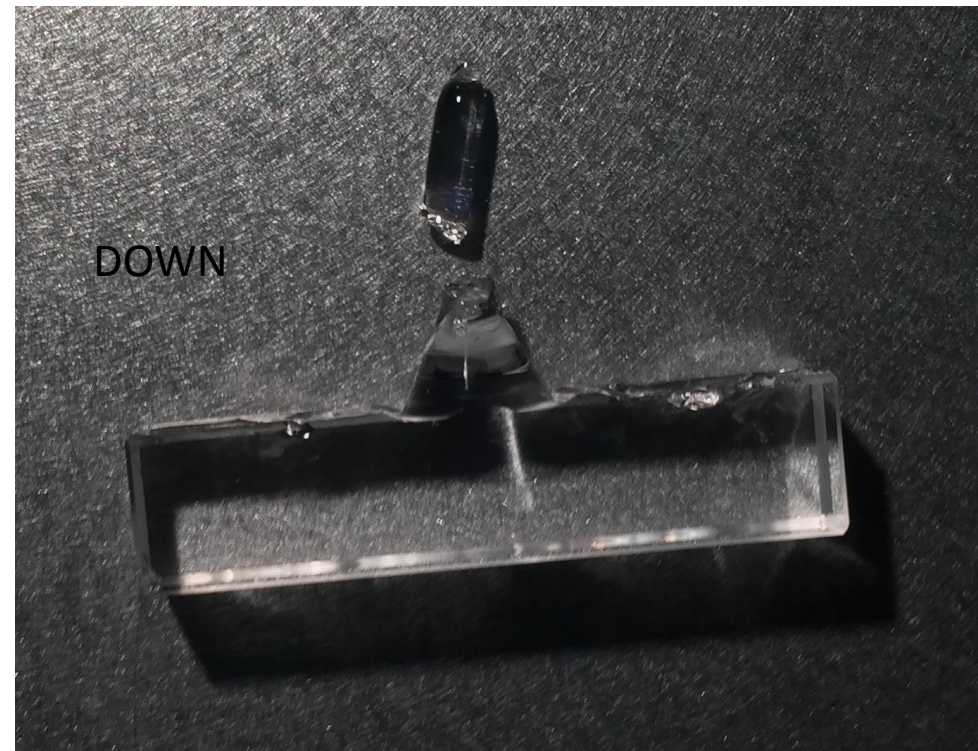
2° WI - Anchors n°3

According to the data the crash begun from this fiber. The anchors performed as expected. The failure started at the level of the fiber (or at the level of the 3mm bar close to the welding).

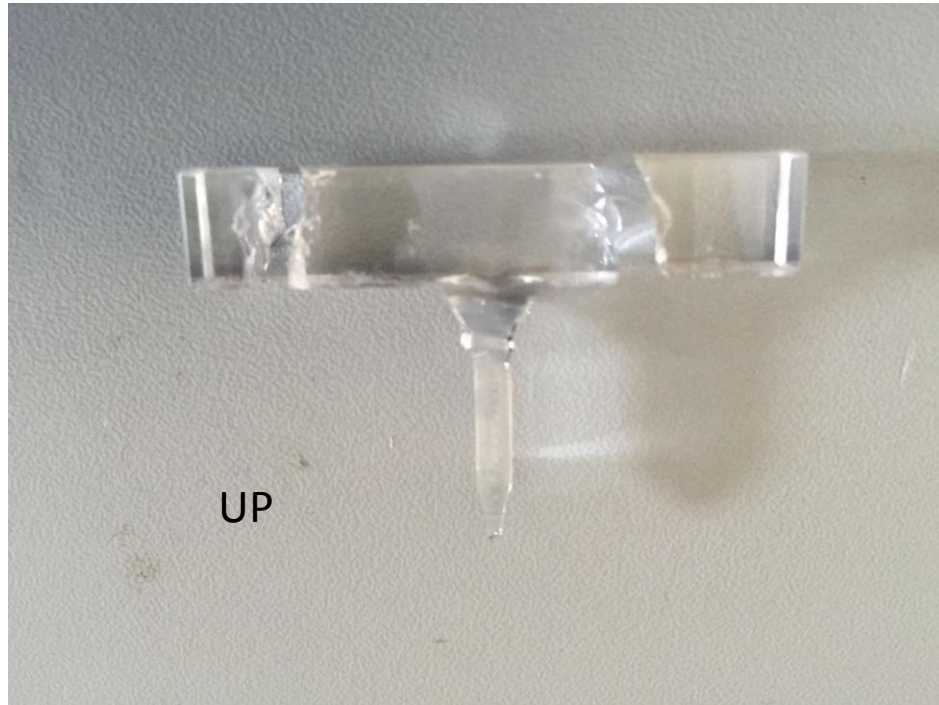
WE - Anchors n°3

According to the data the crash begun from this fiber..it seems that the failure was induced by the fiber
