Compared analysis of payload failures

Helios Vocca &

Flavio Travasso

17/03/2016

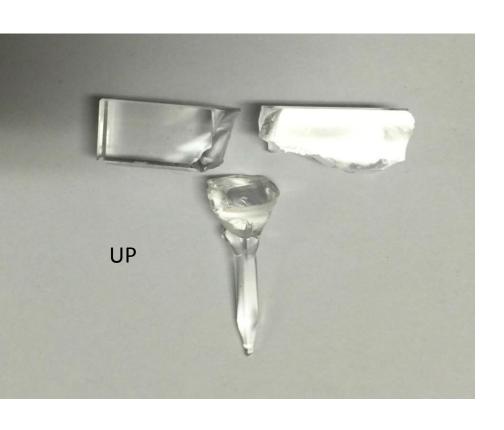
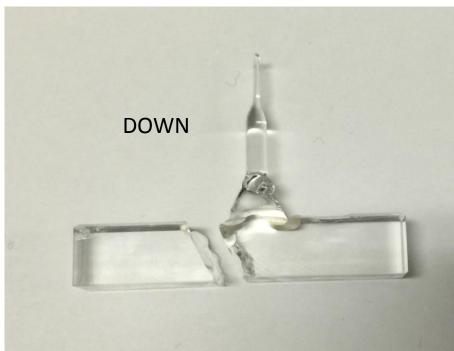
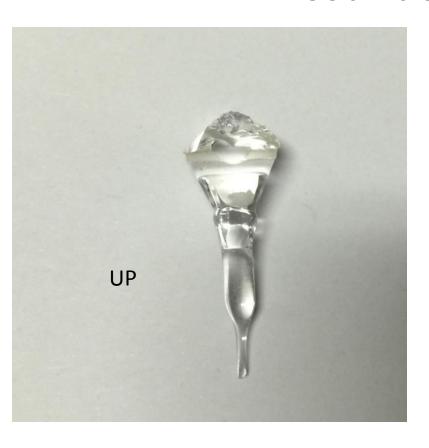
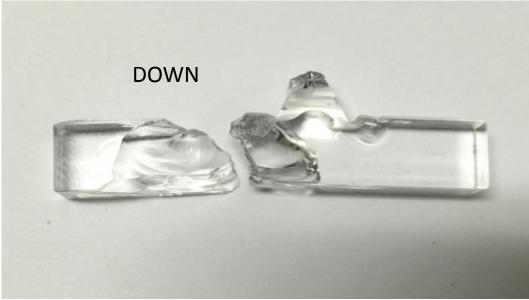
According to the data the crash begun from this fiber: it can be started from the lower cone (or at least from the upper welding...).

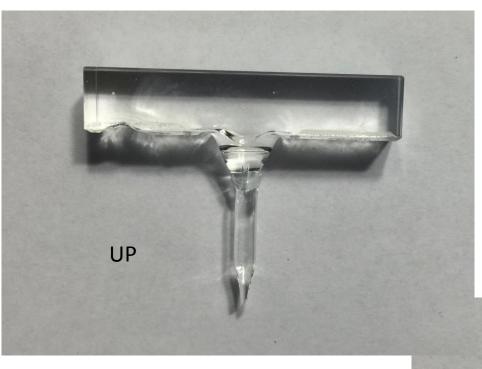
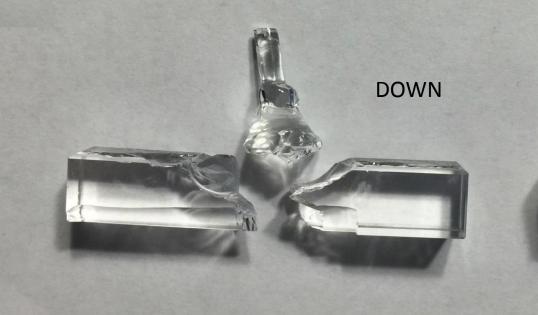
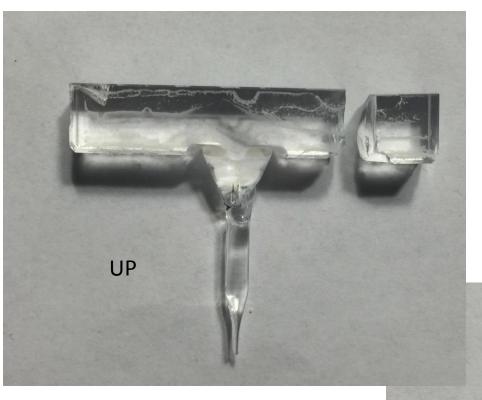
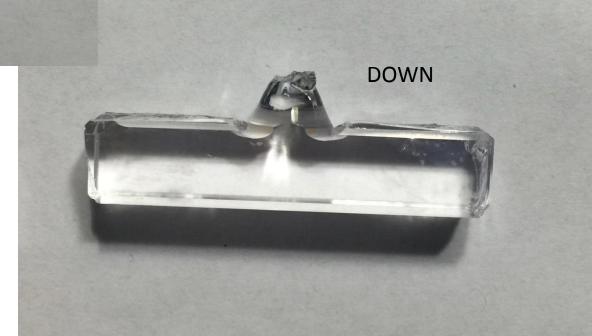
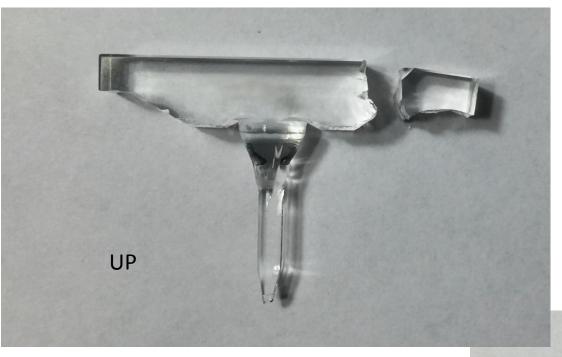
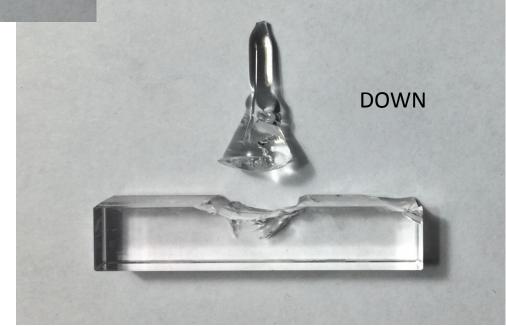
According to the data the crash begun from this fiber: it seems to be started from the lower cone that appears to be opened by a traction from the top, while the upper anchor crash has been caused by a pressure from the bottom to the top as a reaction.

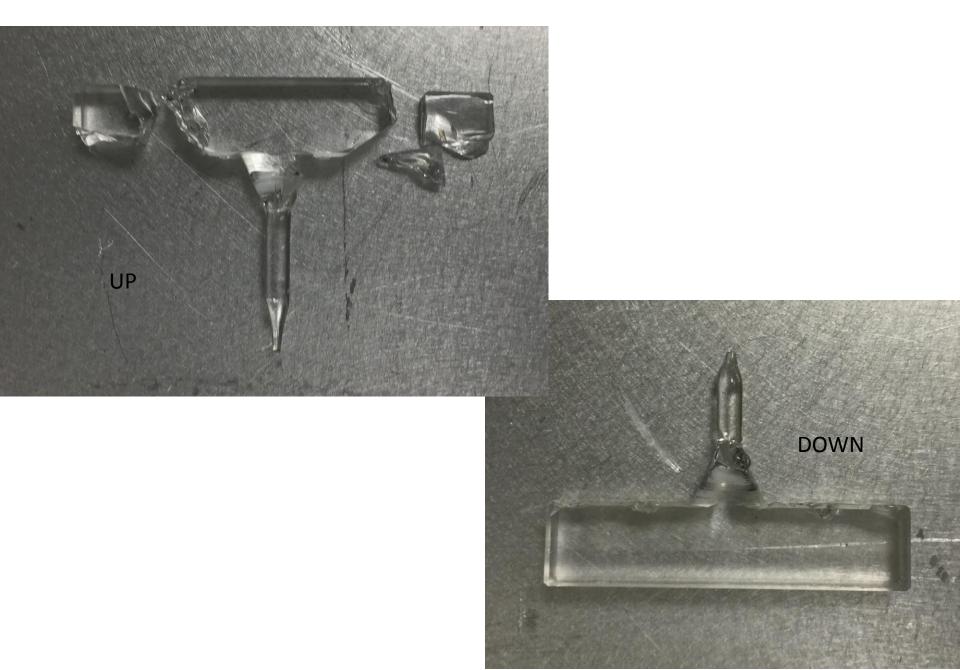
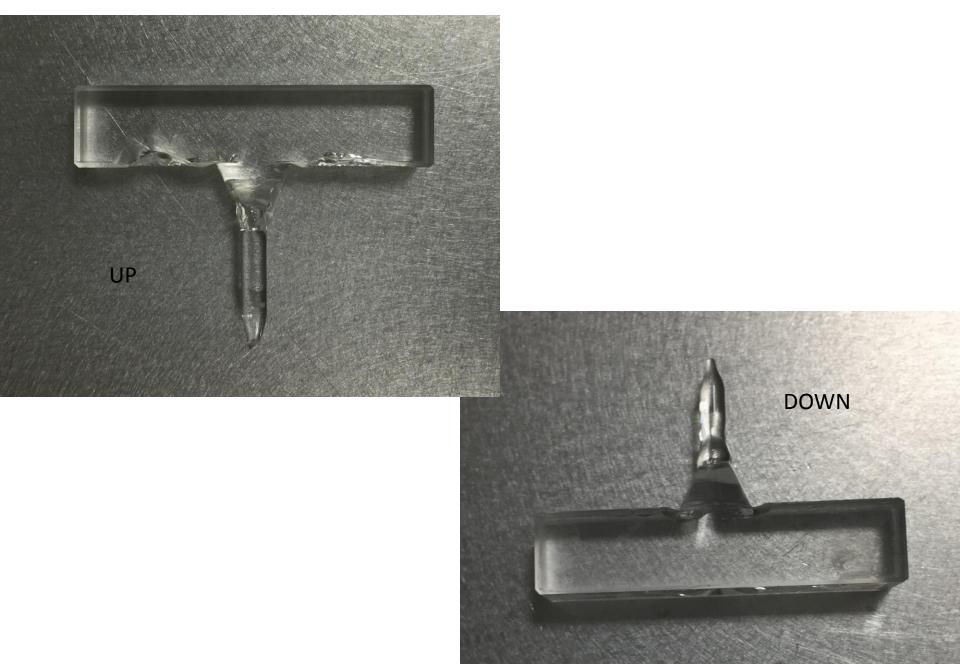
According to the position of the mirror after the crash, the break of the FS suspension begun from this fiber: the two anchor crashes have been caused by a compression force so from a release of energy started from the fiber.

In this suspension the anchors performed as expected.

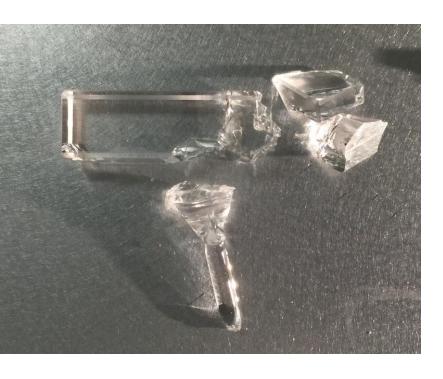
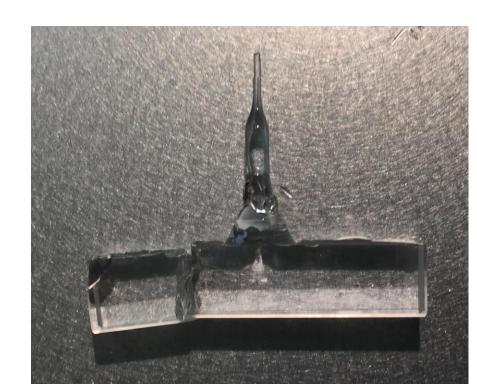
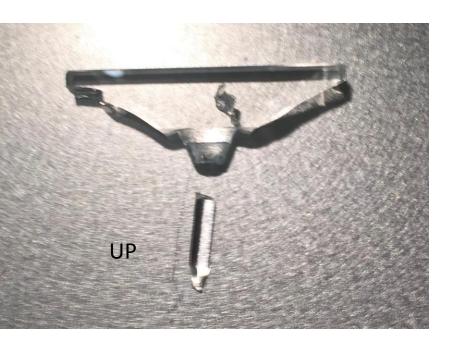
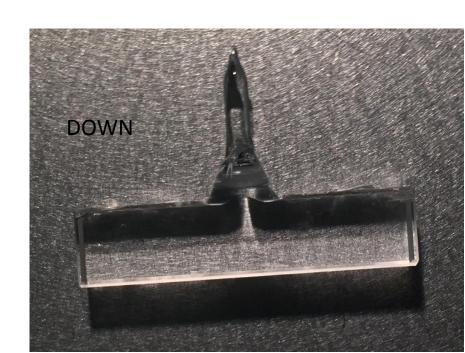
According to the data the crash begun from this fiber. The anchors performed as expected. The failure started at the level of the fiber (or at the level of the 3mm bar close to the welding).

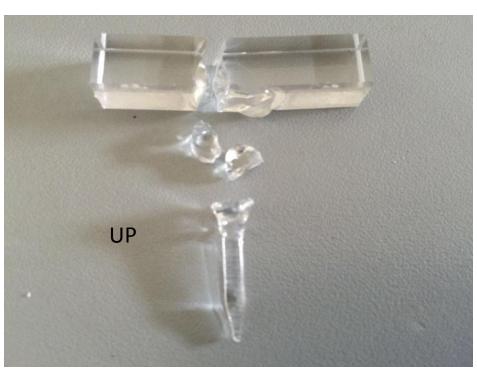
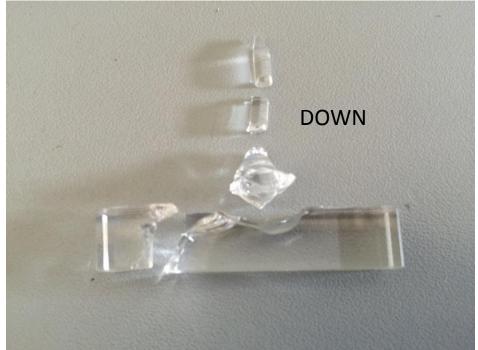
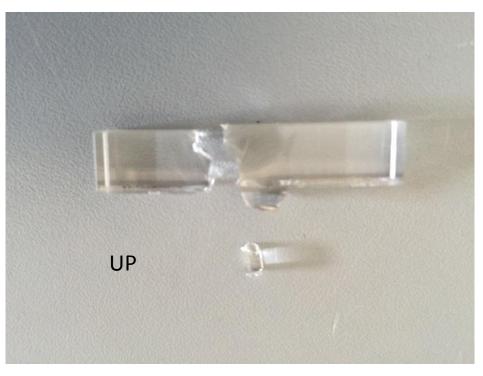
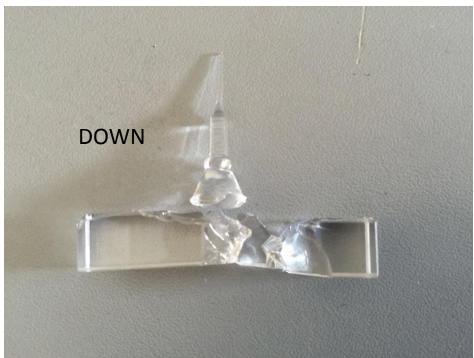
According to the data the crash begun from this fiber..it seems that the failure was induced by the fiber
