Compared analysis of payload failures

Helios Vocca

Flavio Travasso

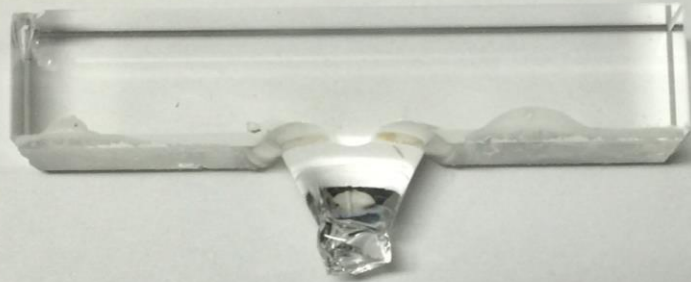
WI - Anchors n°3

According to the data the crash begun from this fiber: it can be started from the lower cone (or at least from the upper welding...).

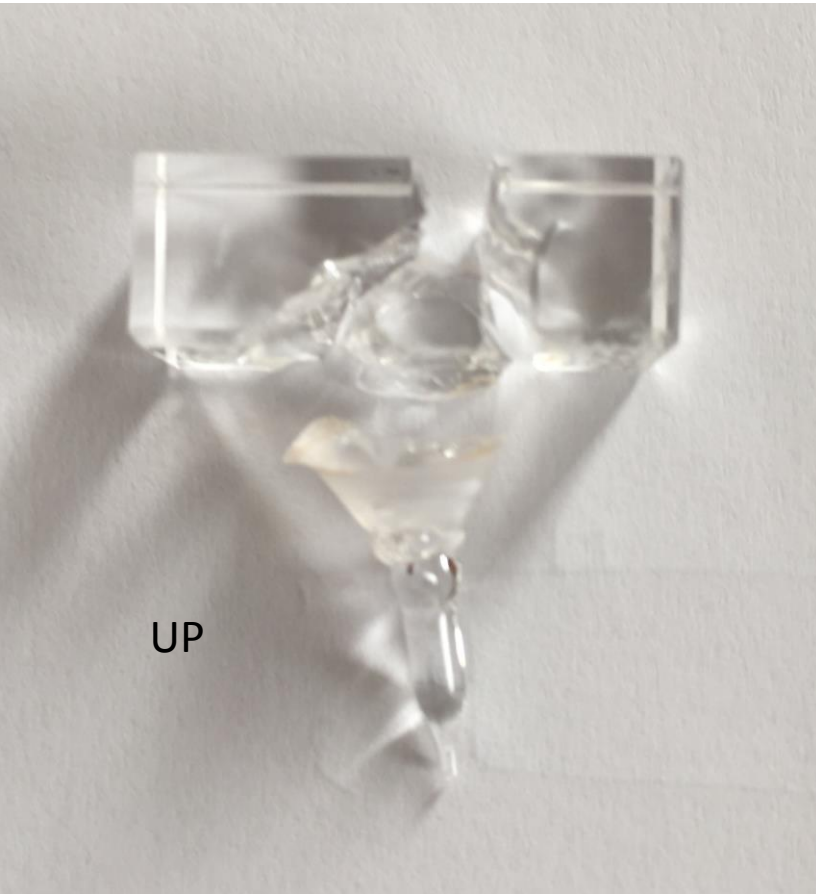
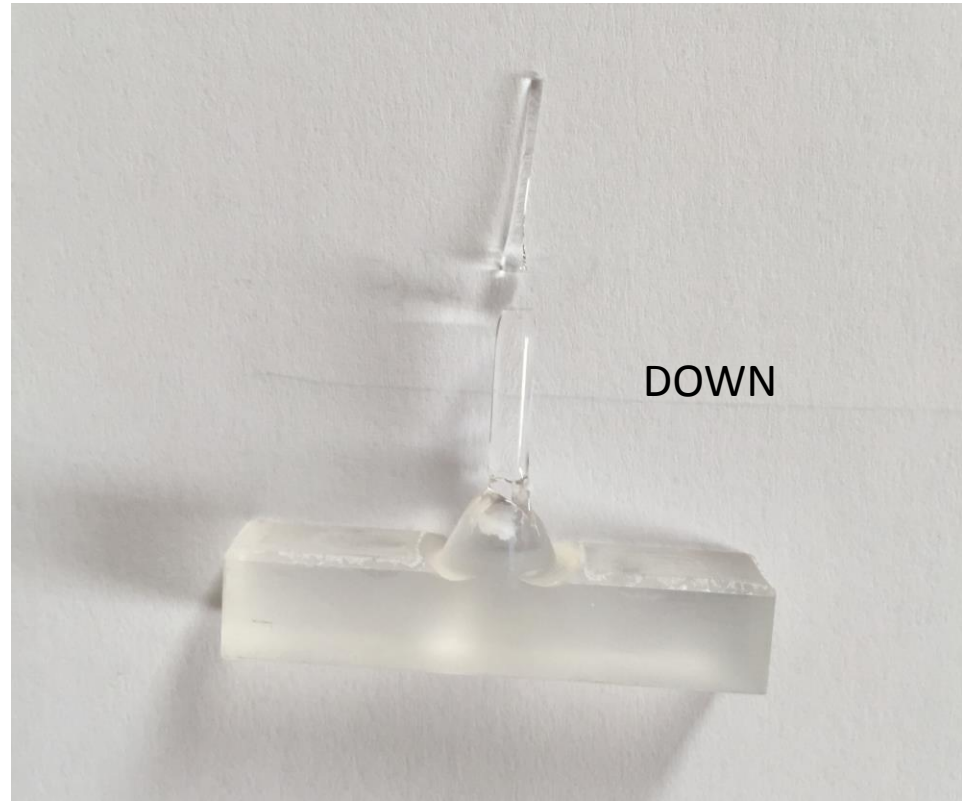
WI dummy- Anchors n°2

The fiber 3 and 4 survived,
while fibers 1 and 2 were
broken!

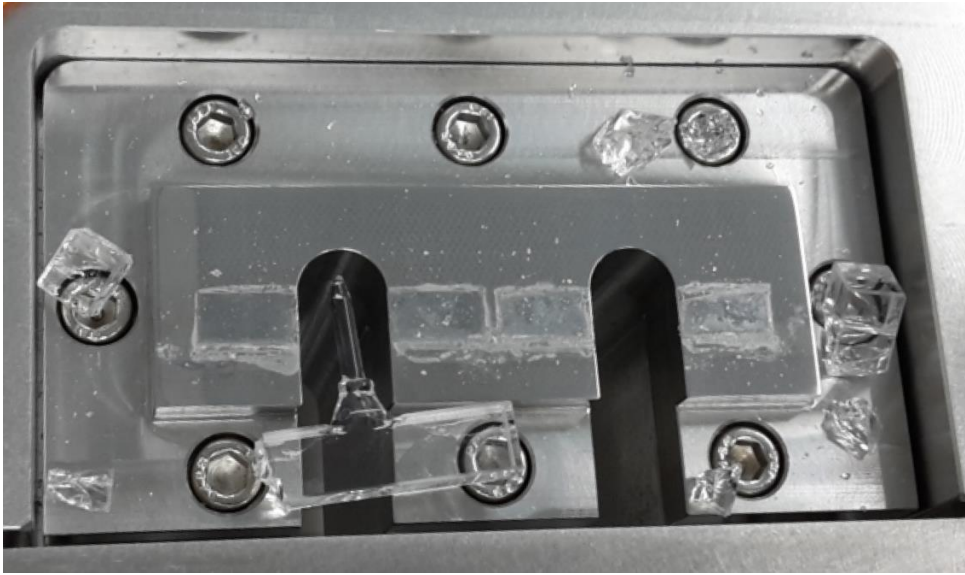
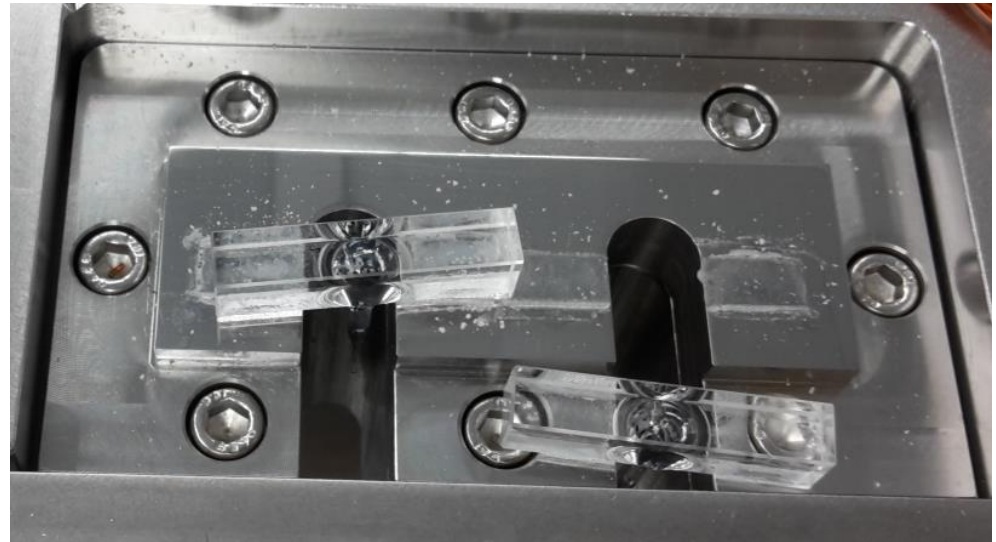
NE - Marionetta view after the crash

The samples are under spectroscopy analysis and these pictures are temporary but not the conclusions.

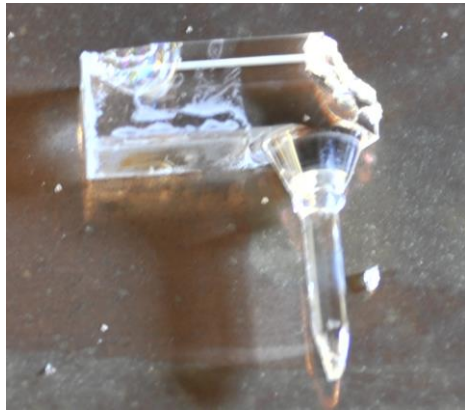
NE - Anchors n°2

Felt on the flange

According to the data the failure started from this fibre caused with high probability by the fibre itself, in a region far from the bottom (because of the big energy released on the lower anchor to brake it on the ear and then on the cradle).

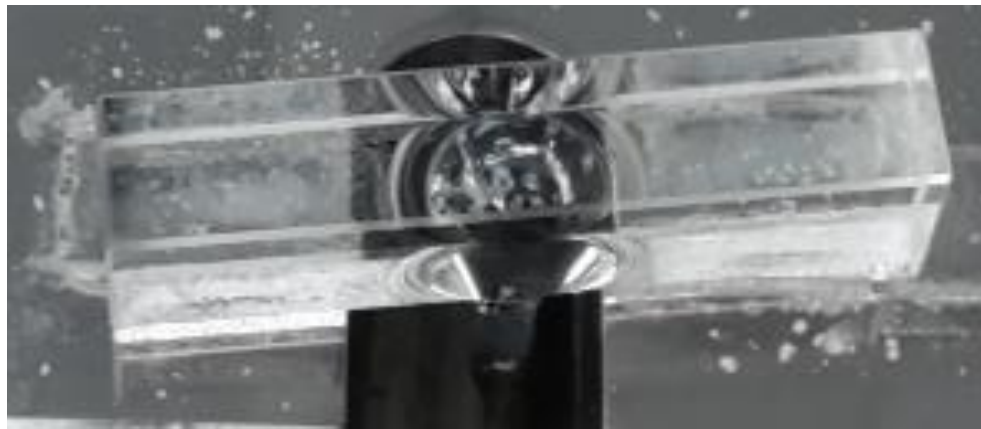
NE - Anchors n°3

Intact on the
Marionetta

Intact on the Ear

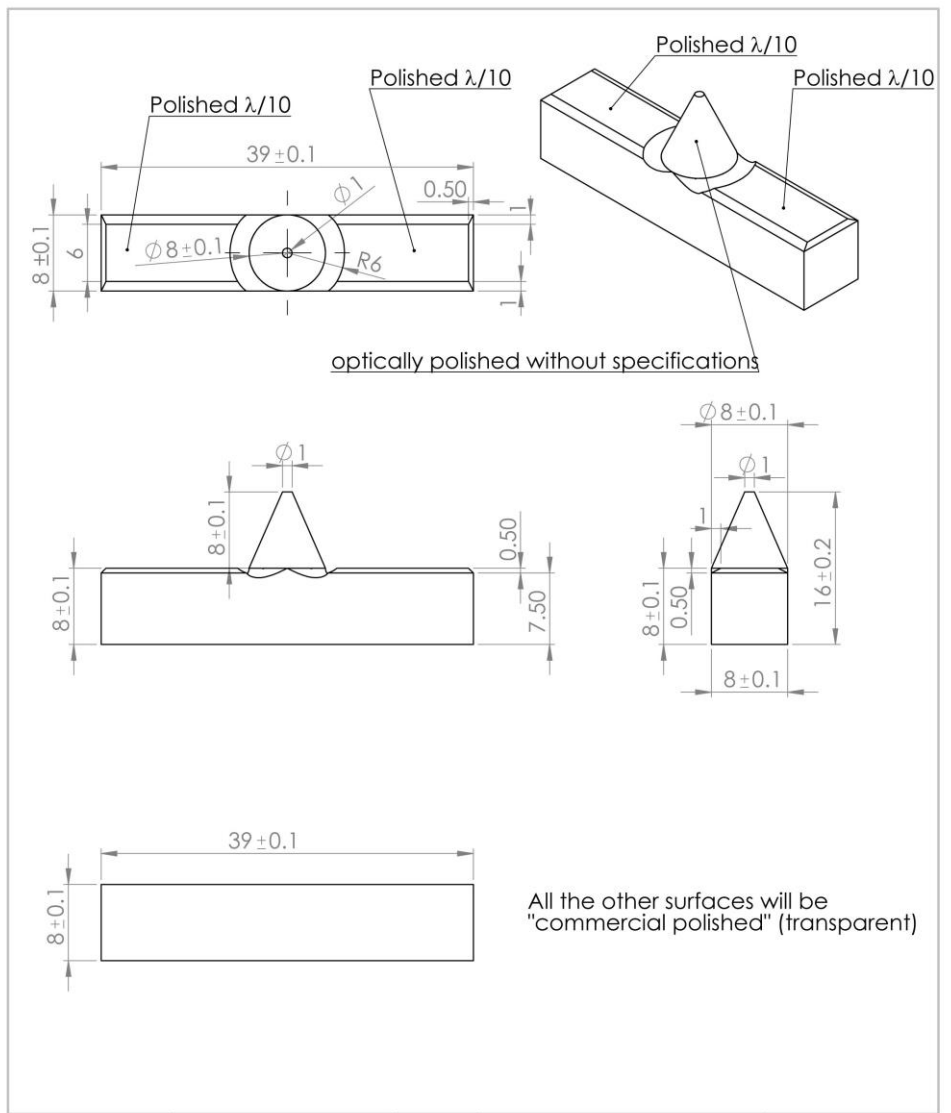
Drawing 1.6 (AdV2)

The SSV experts analyzed the anchors from the first failed fibers of each payload:

- *the breakages of the anchor-bar are probably secondary (i.e. occurred after the suspension's failure), as attested by the estimated breakage stress level and the observed fracture path (Table II);*

- *no breakage began from the lower-surface nor from the sides of the anchor-bar;*
- *the breakages that had started from the rod, at the first thinning ($1.9 \text{ mm} < \phi < 3 \text{ mm}$) and at the welding zone, were secondary, as attested by the breakage stress level (higher than the expected/nominal ones) and the resulting fracture path (flexural vs. uniaxial).*

- *The breakages stresses of the 3 failures occurred at the rod's thinning ($0.8 \text{ mm} < \phi < 1 \text{ mm}$) were comparable to the expected ones. Anyway, only sample "WI I 3D" showed a fracture morphology consistent with an uniaxial stress field at failure, whereas in the remaining two cases a bending stress field was inferred.*

The absence of unquestionable leader fracture origin in any cases but one, strongly suggests that the failures should have started from the missing fragments, i.e. the thinner part of the rods ($\phi < 0.8 \text{ mm}$) or on the 0.4 mm fiber.
